**BODIAM CASTLE  
ROBERTSBRIDGE EAST SUSSEX  
CONSERVATION MANAGEMENT PLAN  
for THE NATIONAL TRUST**

Part 1: UNDERSTANDING AND SIGNIFICANCE

June 2016

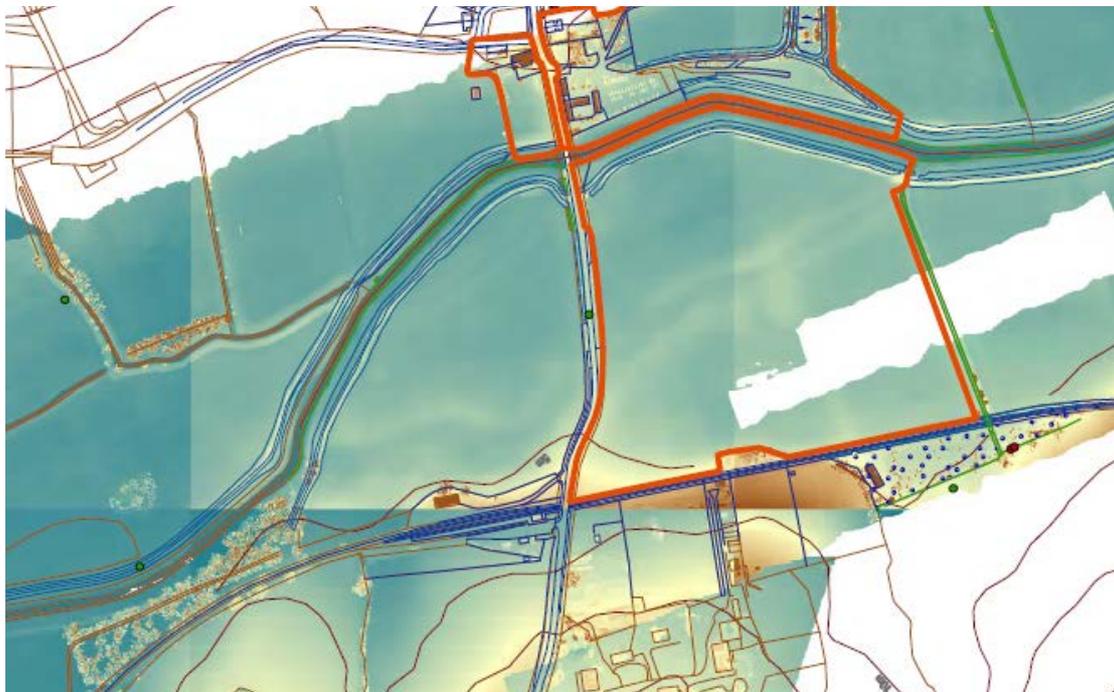
Figure 7 Lidar image of the earlier channel of the Rother, flanked by banks (lighter tone), which brought the stream to the south side of the causeway (LIDAR Composite (November 2013) © Environment Agency)

2.6.18 The earliest known course of the Rother in the vicinity of Bodiam Bridge is clear on Lidar images (Fig 7), part has been recorded in geophysical survey, and sections formed field boundaries recorded by a 1779 estate map.<sup>102</sup> As late as 1945 air photos show a drain, the relict of the back channel which the early course became, intact west of the causeway and as a dark mark in the grass to the east of it, parallel to the then boundary ditch. It is, however, the Lidar image that most clearly illustrates the nature of the underlying feature, a substantial channel with raised banks to both sides.<sup>103</sup>

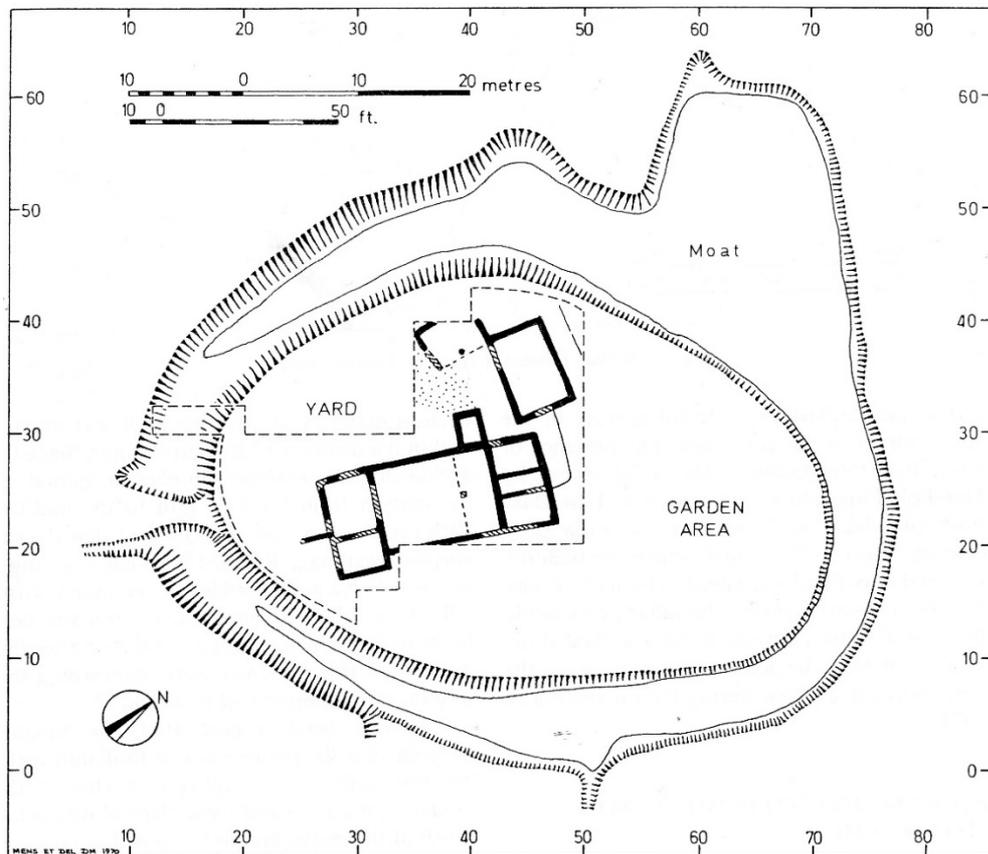
Figure 8 The moated site at Bodiam (Martin 1990, fig 8; *Courtesy David Martin & Sussex Archaeological Society*)

2.6.24 To the north-east of the church is an oval moated enclosure, almost on the valley floor of the Kent Ditch, its southern side cut into the rising ground of the valley slope. The moat has a wide arm extending north-westwards along the valley, and the entrance was by a bridge from the west, from which a gravel path led to the porch of the house. Excavation<sup>113</sup> revealed a house with a central open hall c10.2 x 7.6m internally, flanked by a parlour cross-wing on the south and a service bay with central passage to an external path on the north, with a porch to the west door of the hall cross-passage (Fig 8). The excavator considered it 'typical of upper vernacular and lower manorial houses'; interestingly, its hall was slightly shorter and a little wider than that of the Castle, 12.2m x 7.3m internally.

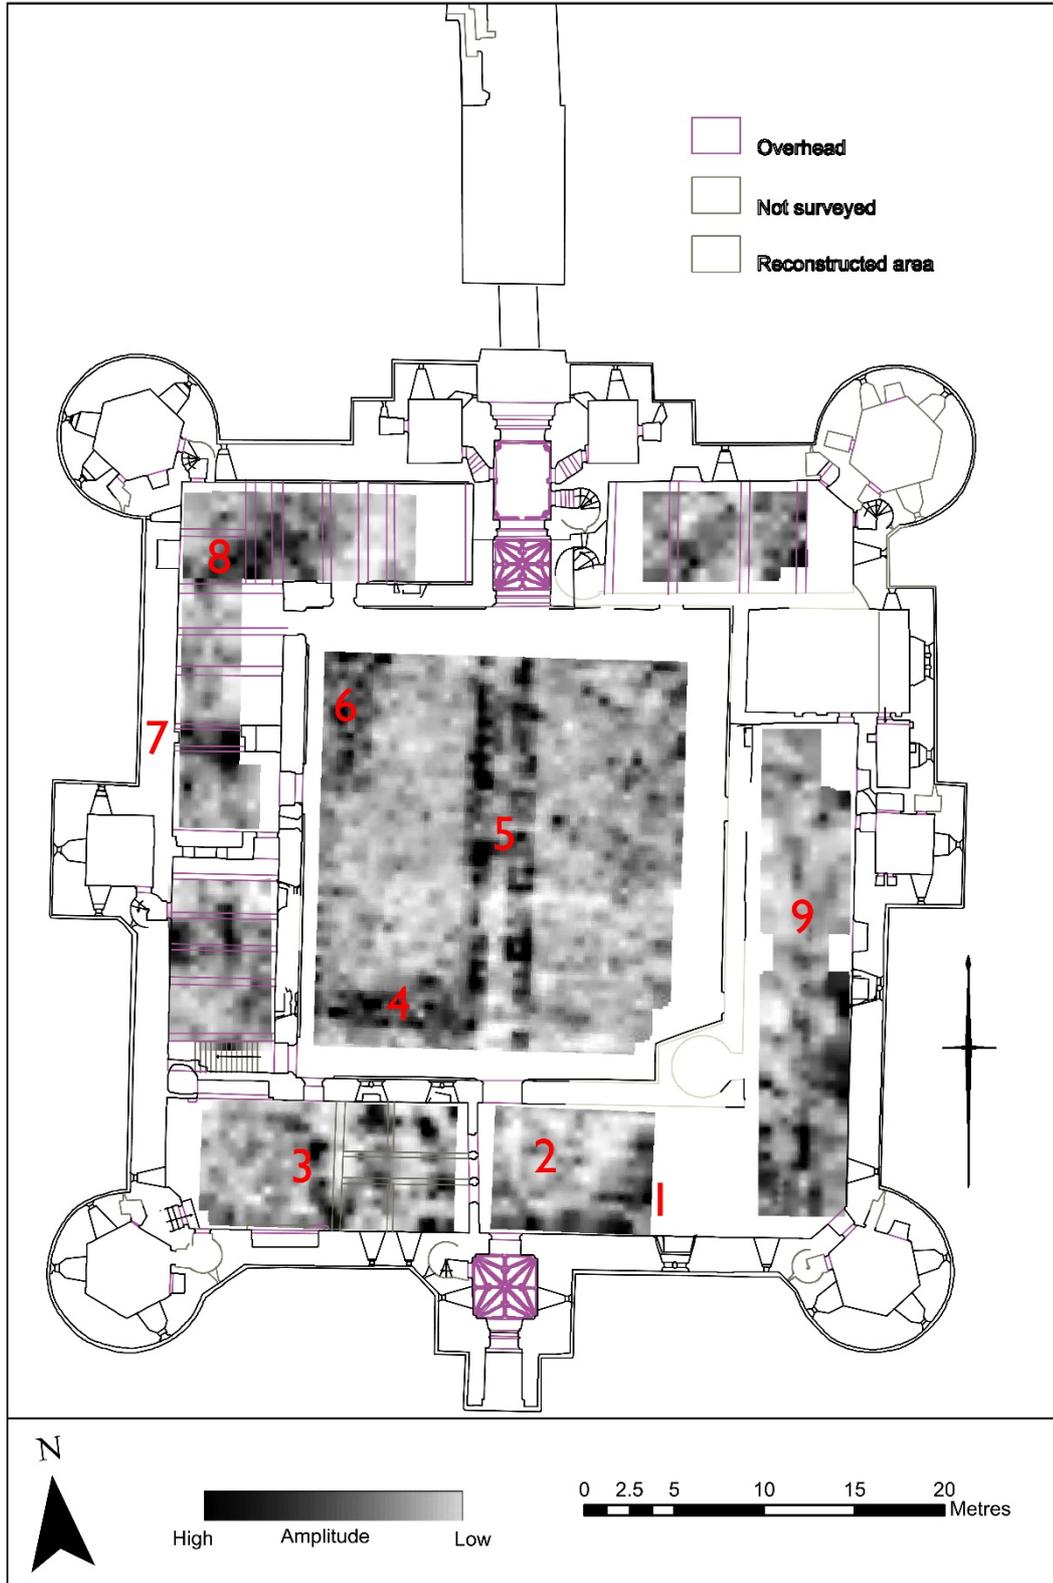
Figure 11 Ground penetrating radar results within the castle, 2016, at high level; the north-east and east range areas are at high level within the basement area (*University of Southampton; numbers added*). The deposits in the east range basement are disturbed at this level, particularly by the modern drain 9 down its spine. The strength of response and persistence in depth of features marking the path across the courtyard (5) is probably due to metal features. The path existed by 1782 (Fig 50)

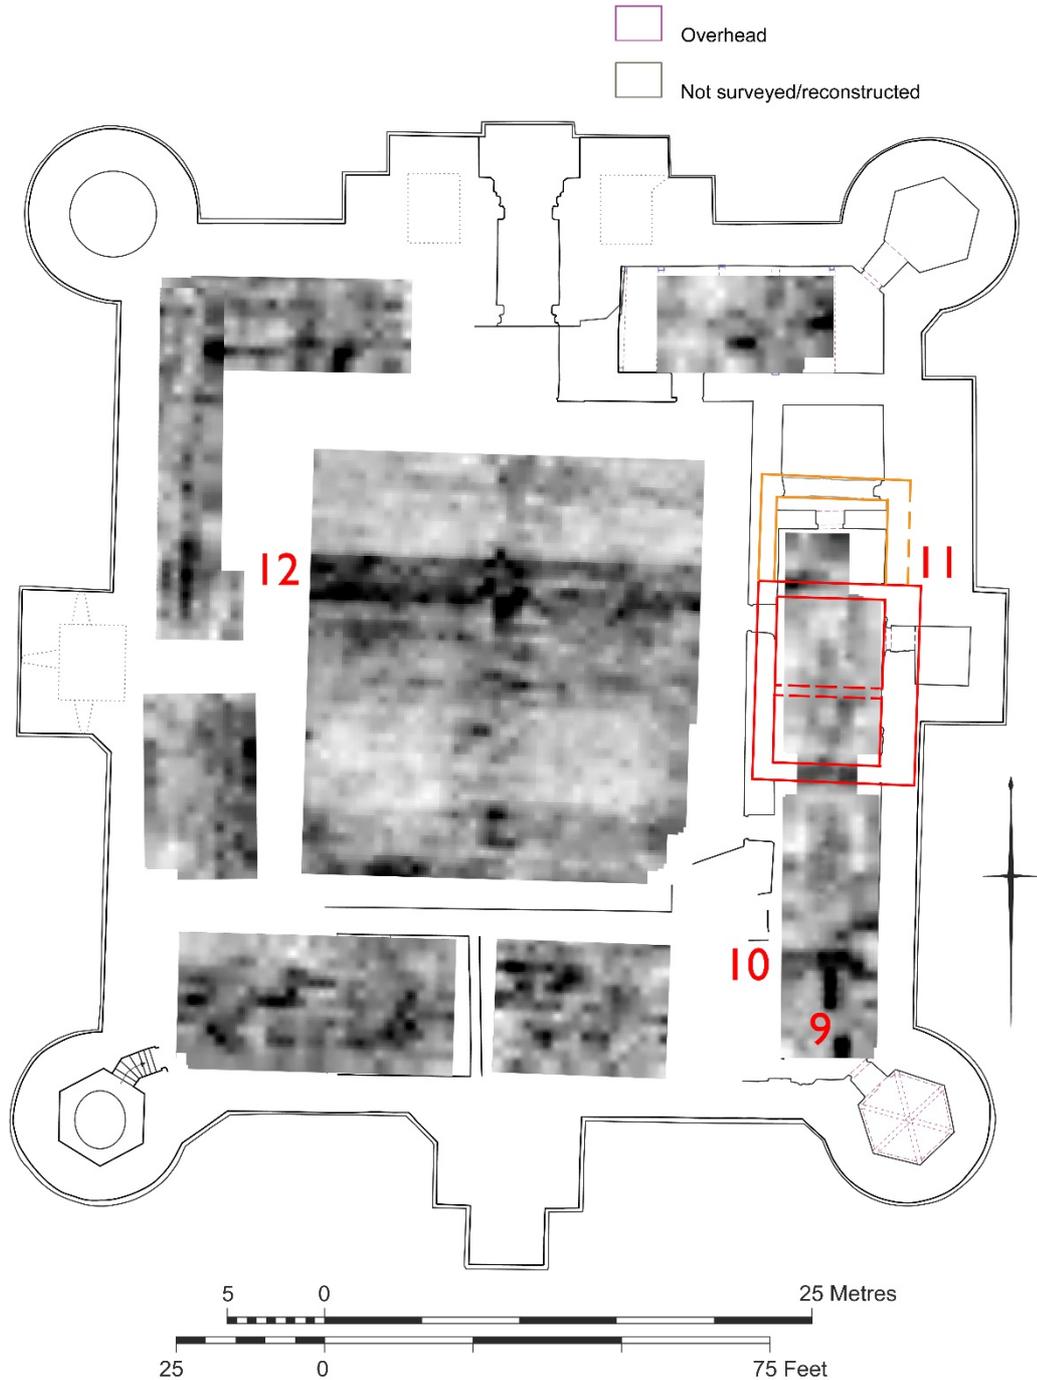
Figure 12 Ground penetrating radar results within the castle, 2016, at lower level: 1.62-1.73m below courtyard level, 0.77-0.88m below basement level in the east and north-east ranges (*University of Southampton, with early structures and numbers overlaid*). The outlines of the successive early masonry structures are shown in red and orange, as on Fig 15, in the context of the anomaly 12 on the same alignment. The anomaly 10 is the foundation of the wall between rooms 0.12 and 0.13, cut by the modern drain 9.

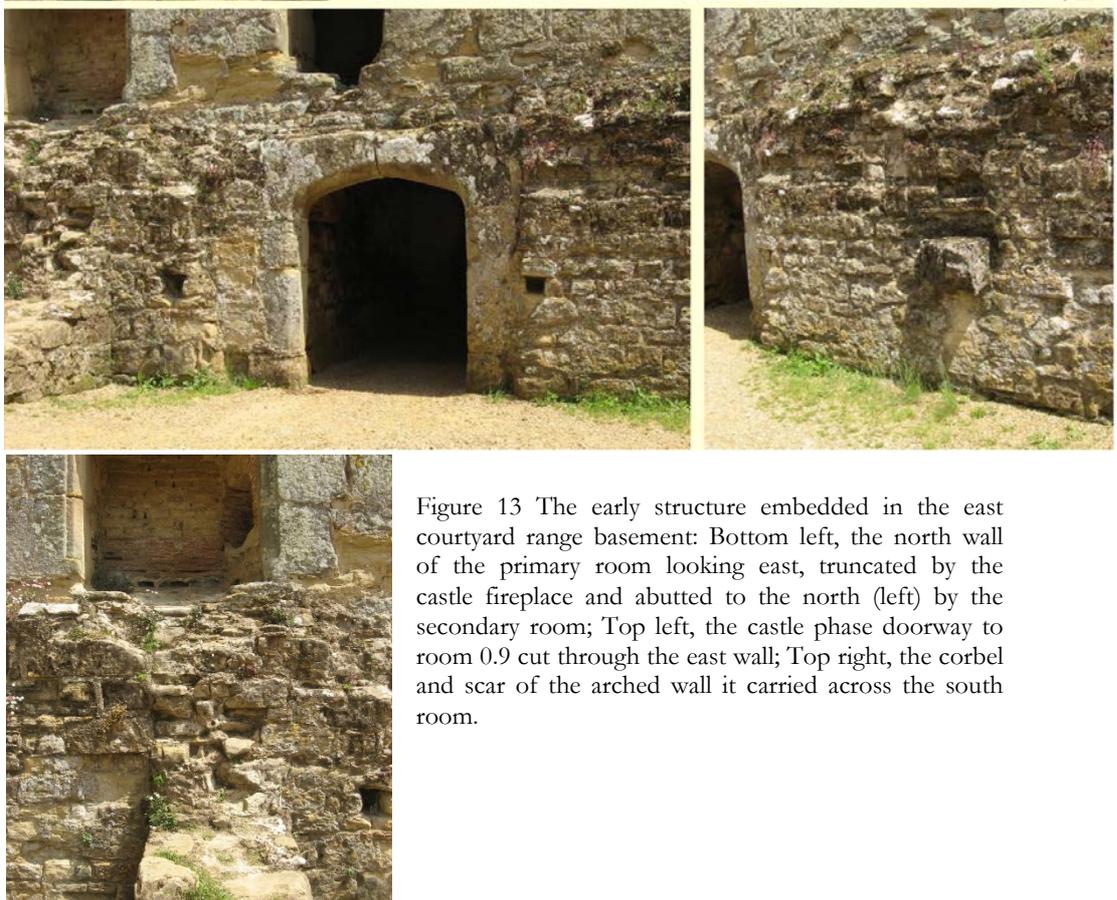
Figure 13 The early structure embedded in the east courtyard range basement: Bottom left, the north wall of the primary room looking east, truncated by the castle fireplace and abutted to the north (left) by the secondary room; Top left, the castle phase doorway to room 0.9 cut through the east wall; Top right, the corbel and scar of the arched wall it carried across the south room.

- 2.8.5 The only architectural feature to survive adaptation as part of the substructure of the castle is an off-centre rectangular corbel on the east wall, about 0.5m wide, above which is the scar of a cross wall, presumably carried on an arch sprung from the corbel. Its presumed twin on the west wall has apparently been removed by a castle phase window, but the window and flanking masonry have been refaced (or rebuilt) to both sides. A doorway is possible to the south, where the wall is damaged, as is one in the north-west corner where the wall is lost above ground.<sup>141</sup>

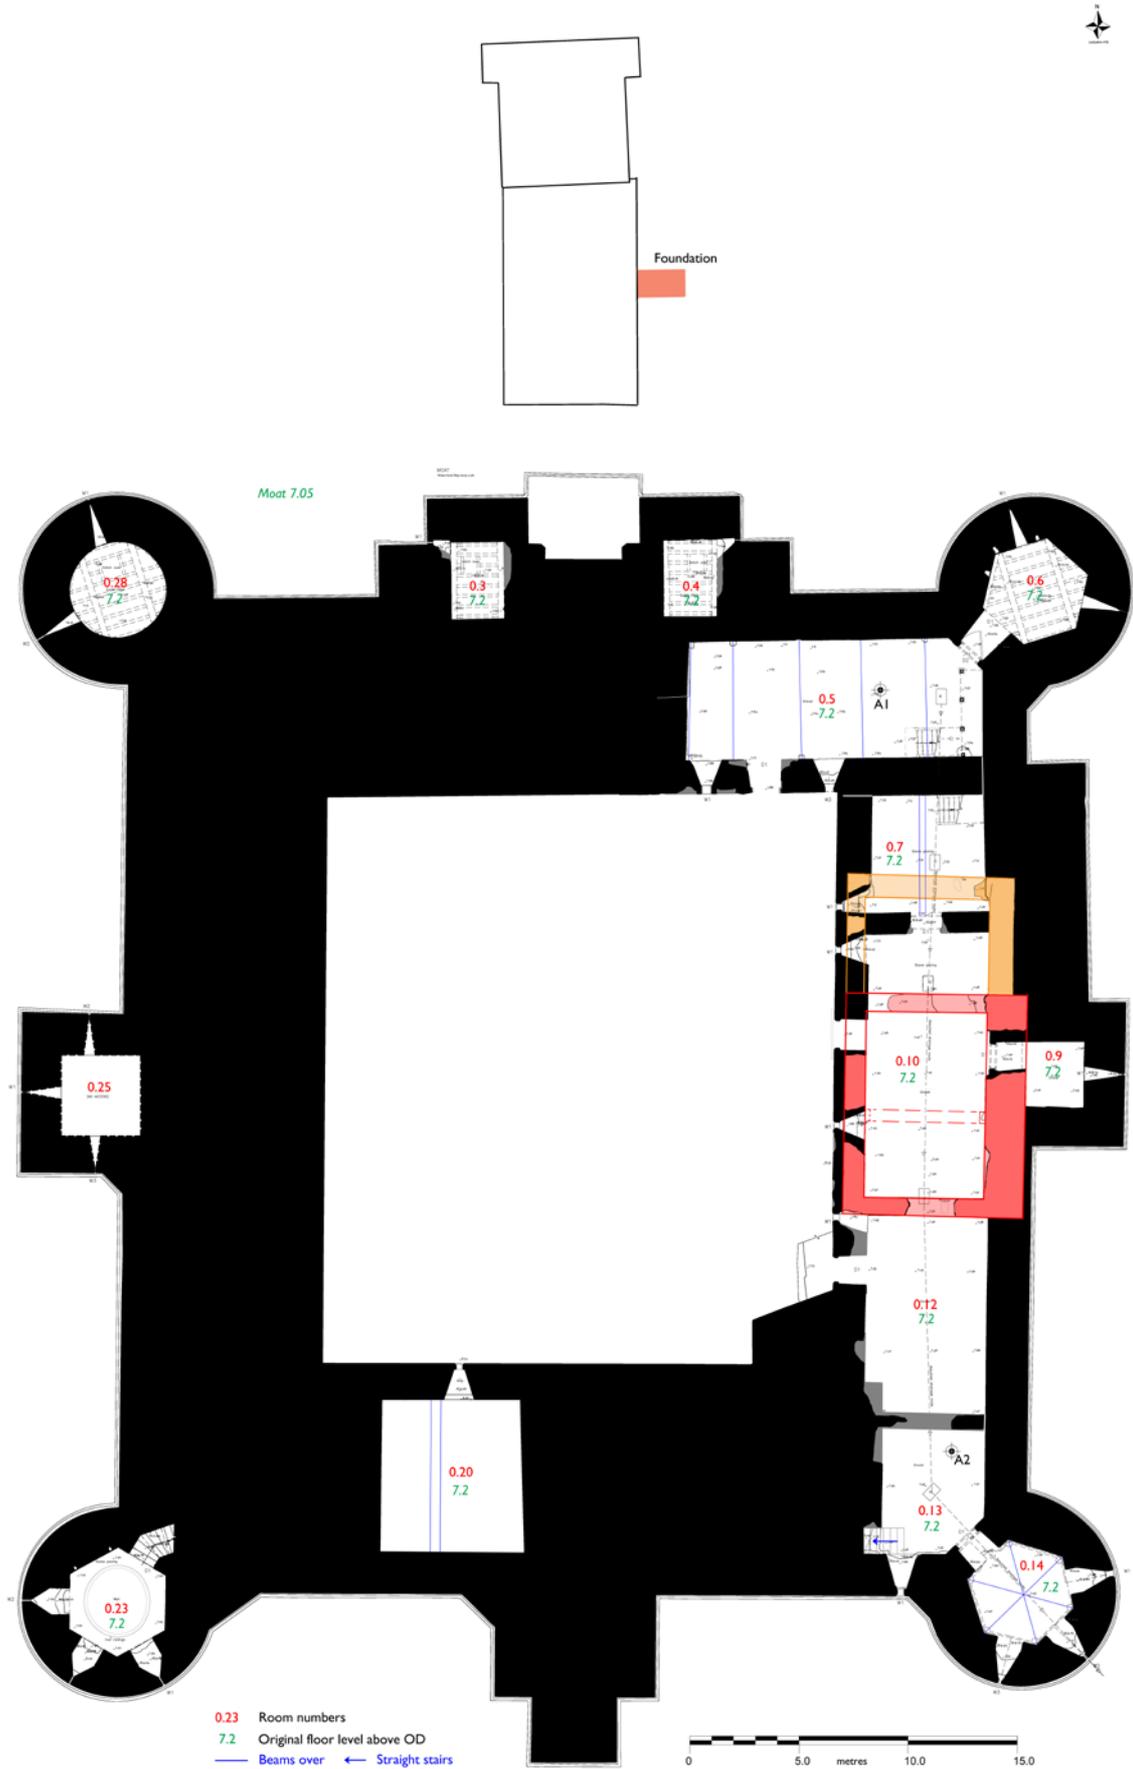
Figure 15 Bodiam Castle: Basement plan (based on a survey by James Brennan Associates). Early masonry is shown red (primary) and orange (secondary); reconstructed lines and walls in grey tone

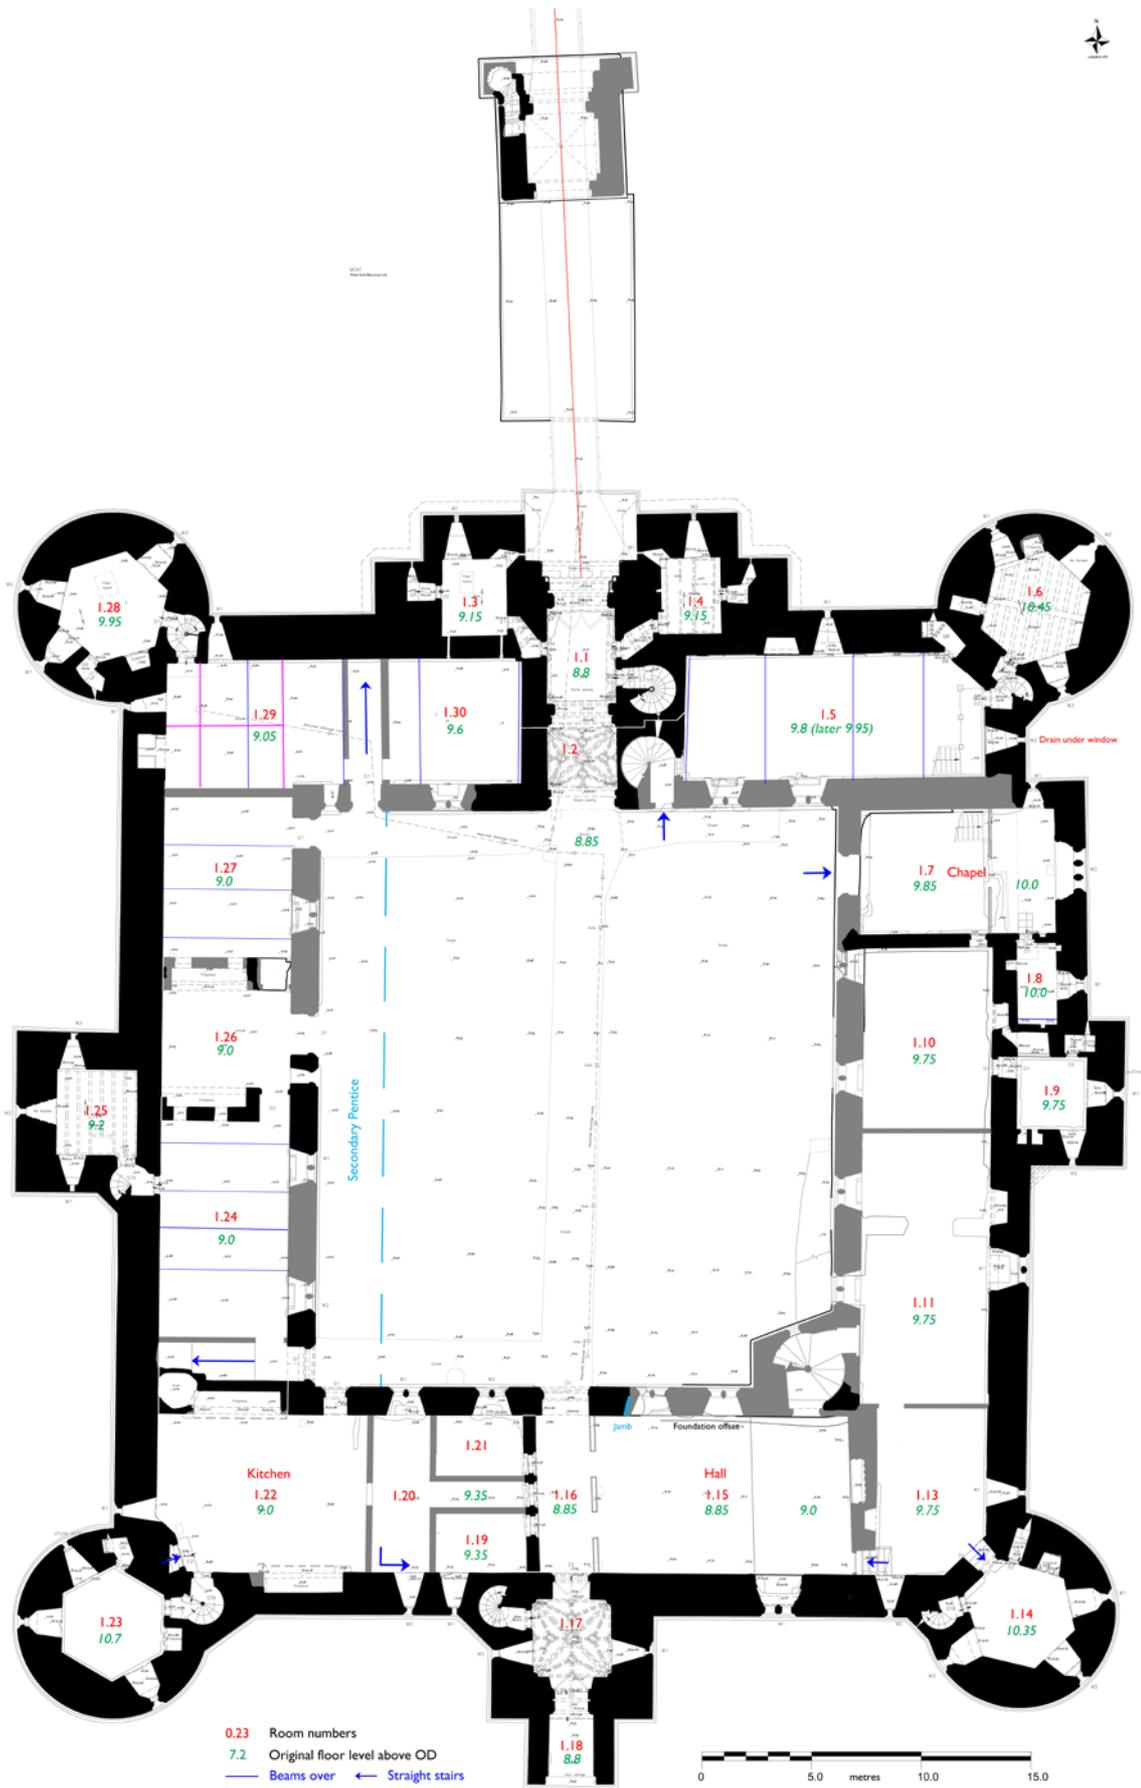
Figure 16 Bodiam Castle Ground Floor Plan (based on a survey by James Brennan Associates); reconstructed lines and walls in grey tone

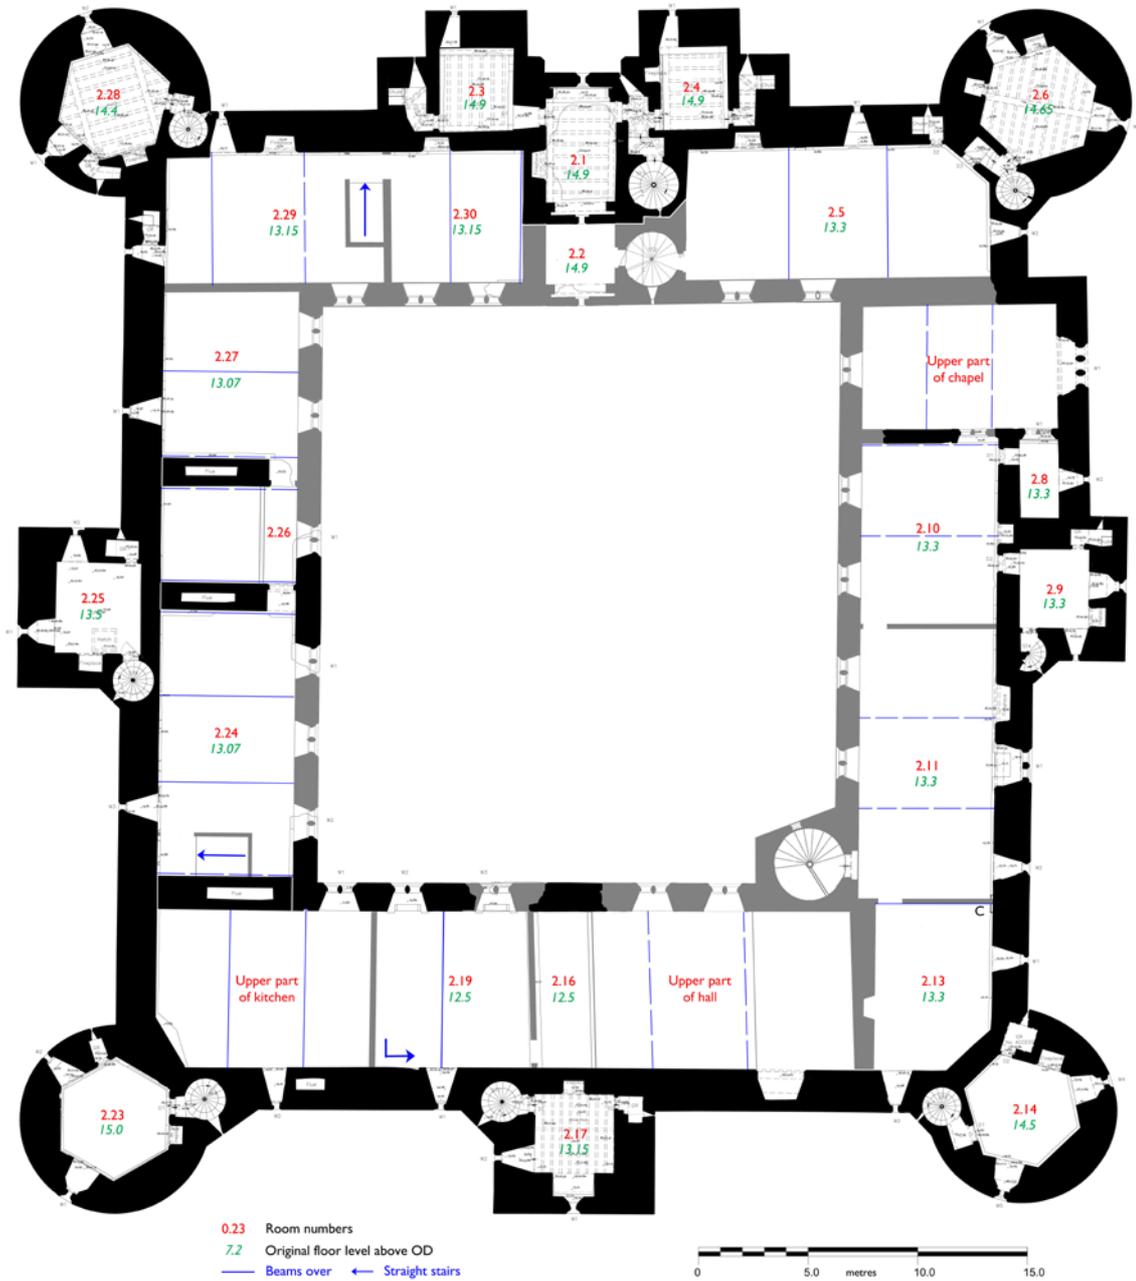
Figure 17 Bodiam Castle First Floor Plan (based on a survey by James Brennan Associates); reconstructed lines and walls in grey tone

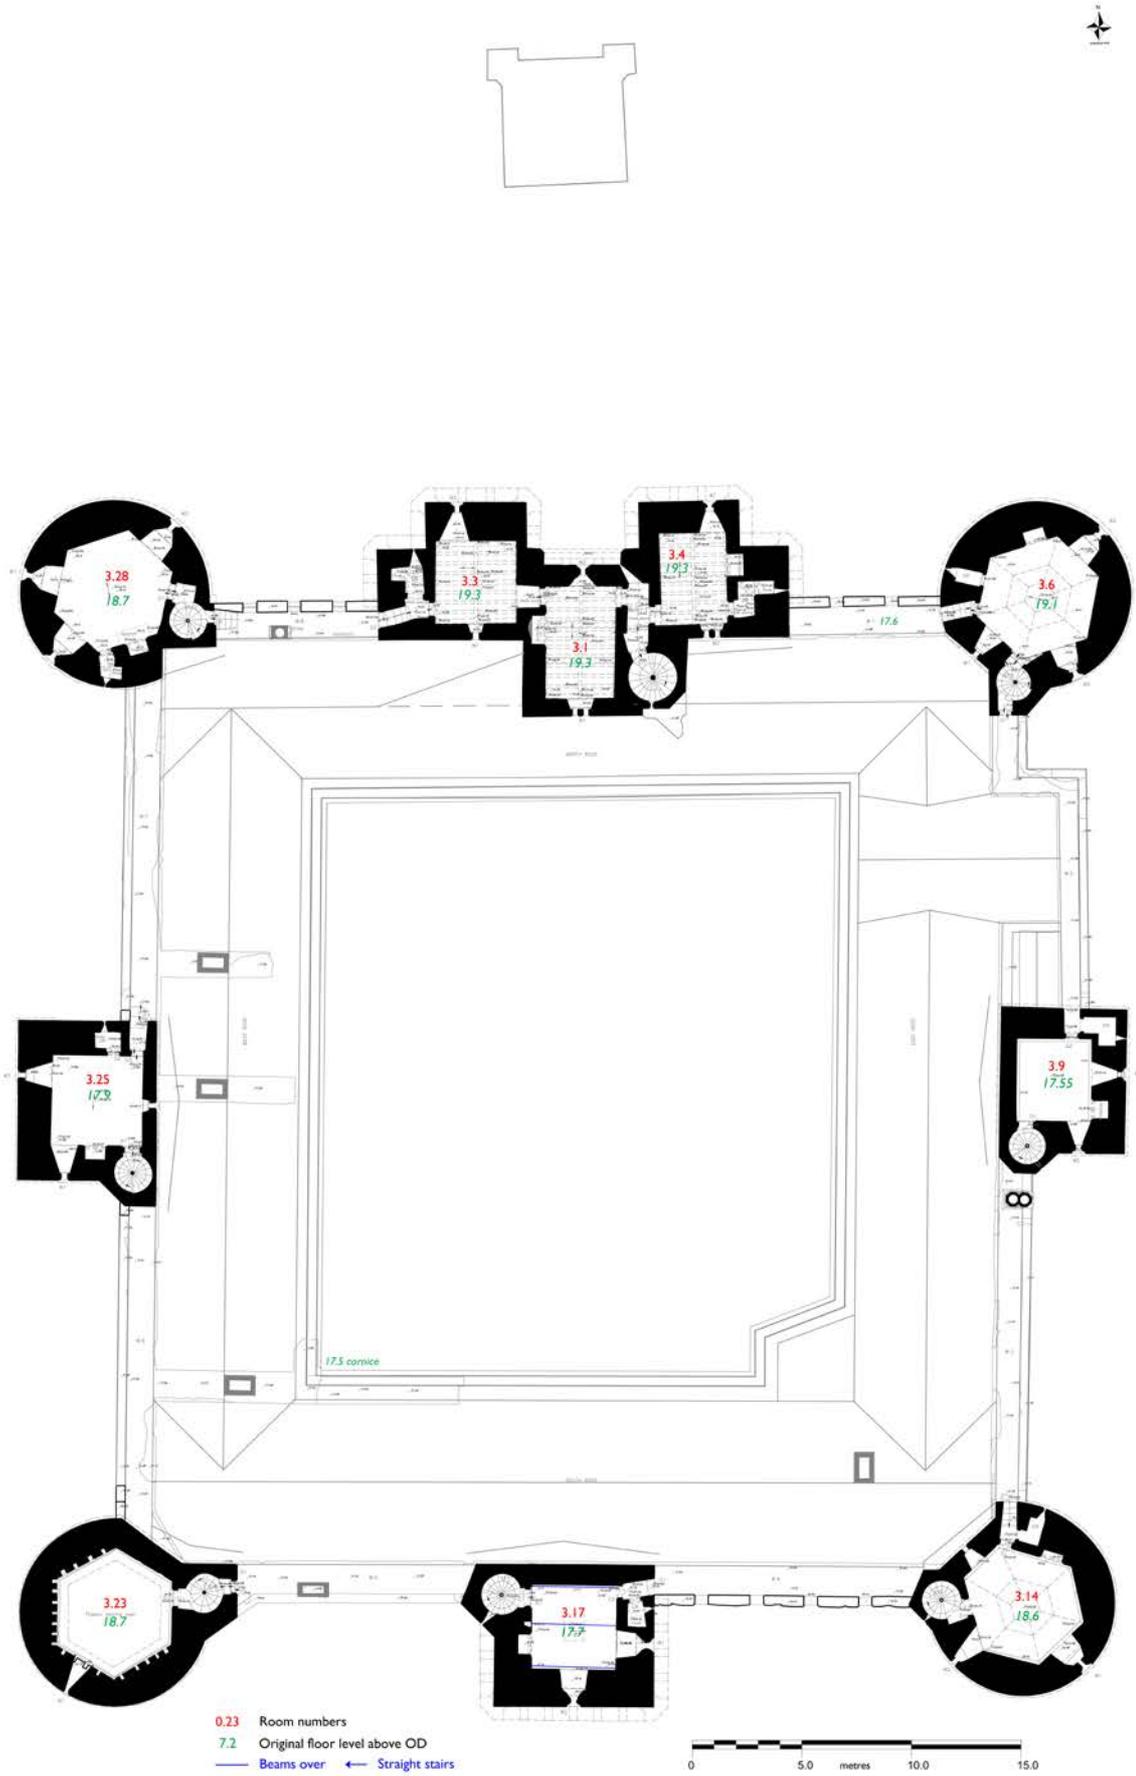
Figure 18 Bodiam Castle Second Floor Plan (based on a survey by James Brennan Associates); reconstructed lines and walls in grey tone

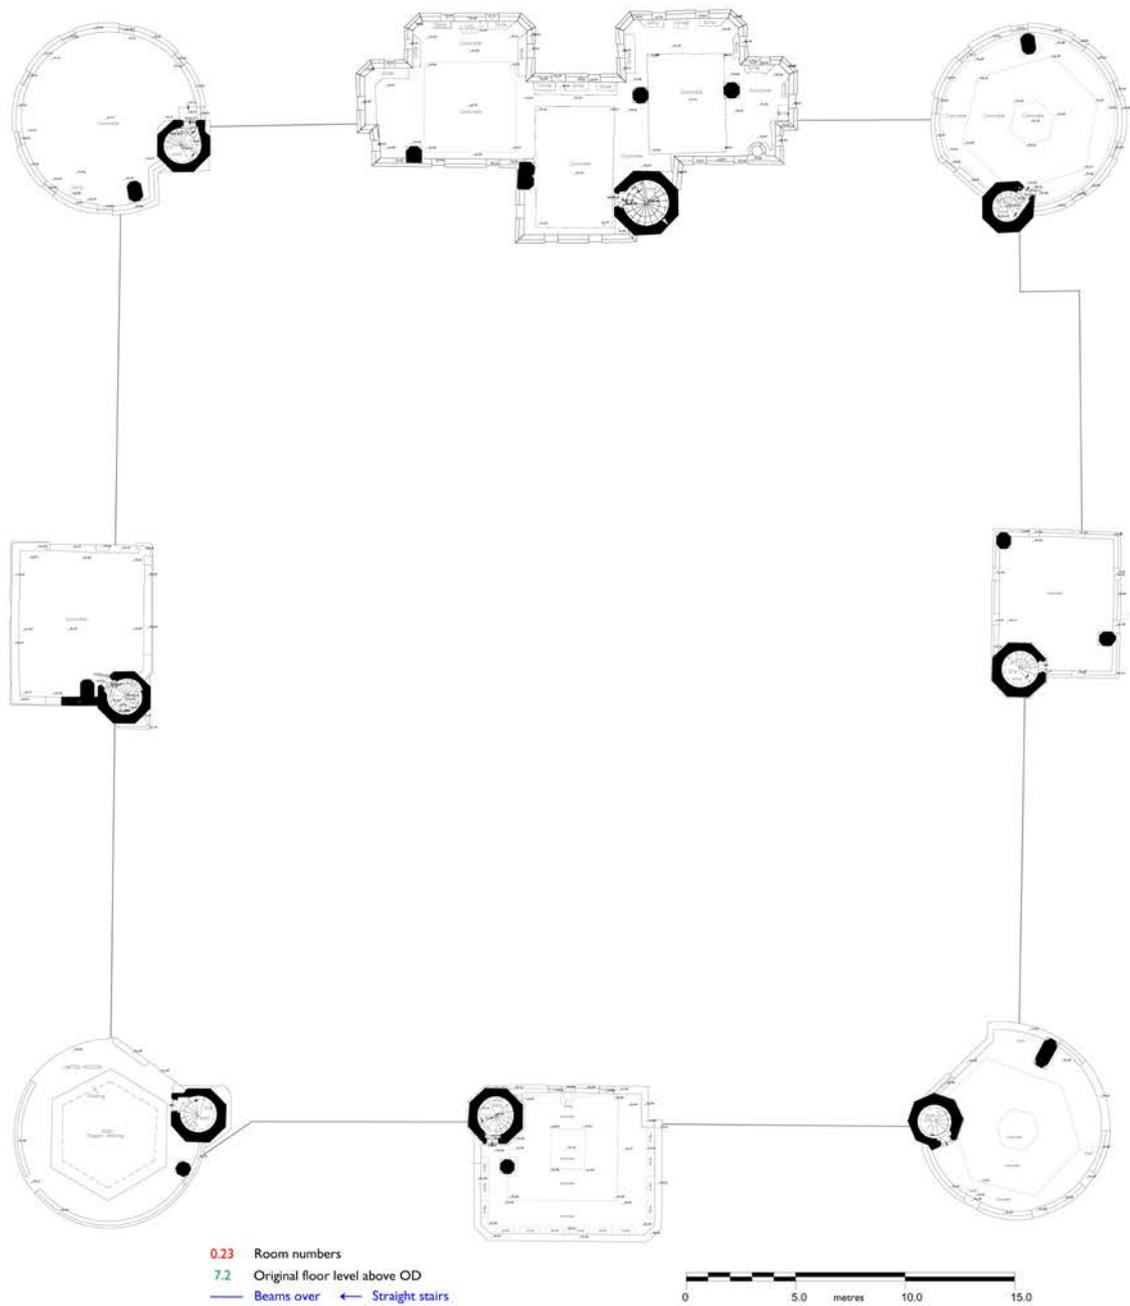
Figure 19 Bodiam Castle Third Floor Plan (based on a survey by James Brennan Associates); reconstructed lines and walls in grey tone

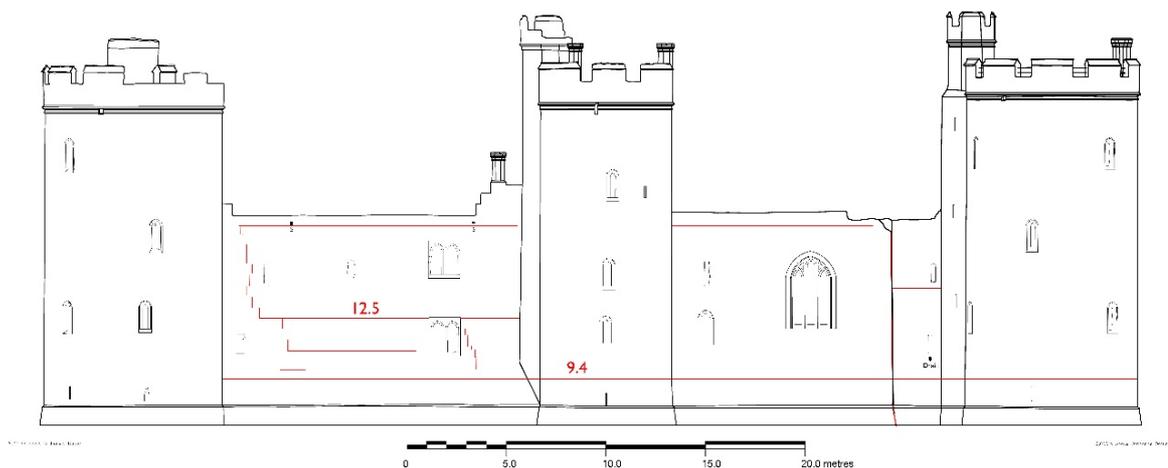
Figure 21 The east elevation of Bodiam Castle, showing some of the more prominent construction joints

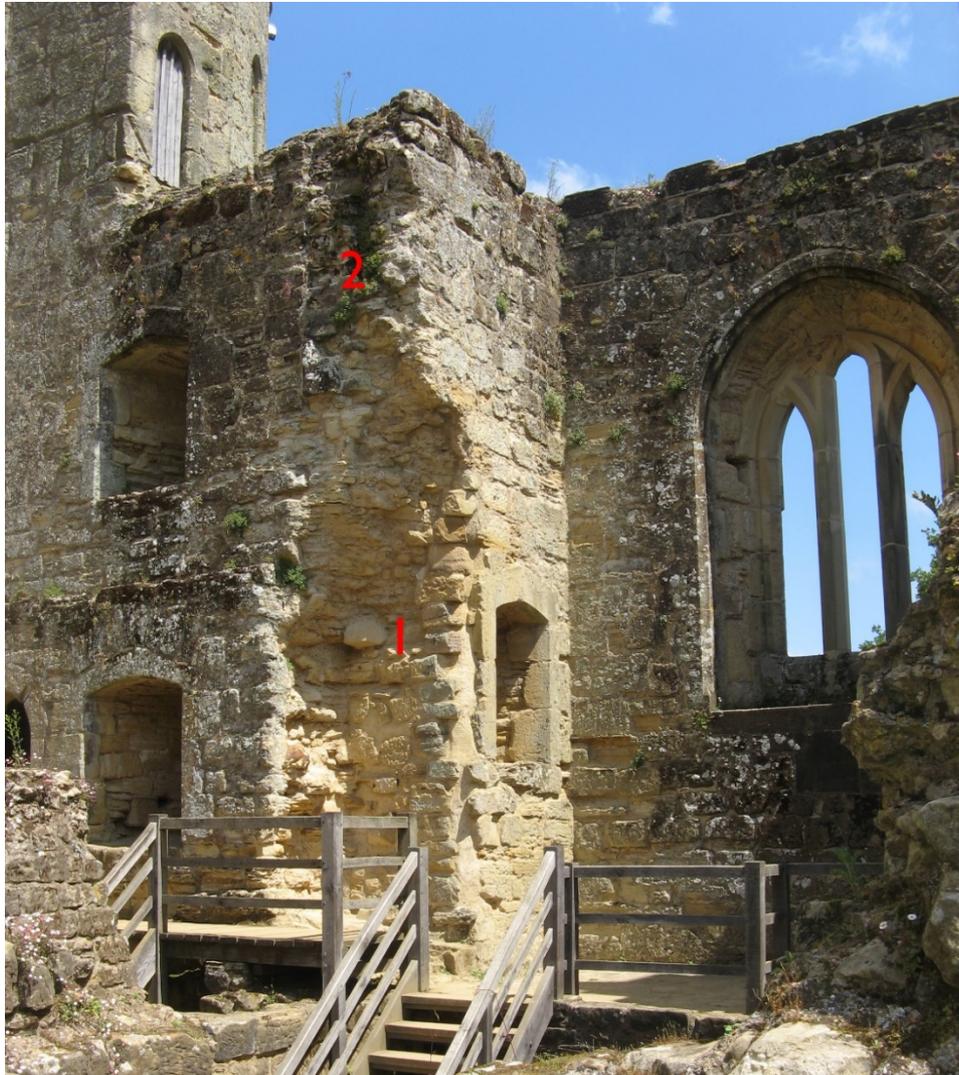
Figure 22 The NE corner of the chapel. The north wall abuts the east below the platform; over-rides it through the lower stage above (1; the back of the recess caused by its removal has been built out in modern work), and bonded with it above (2)

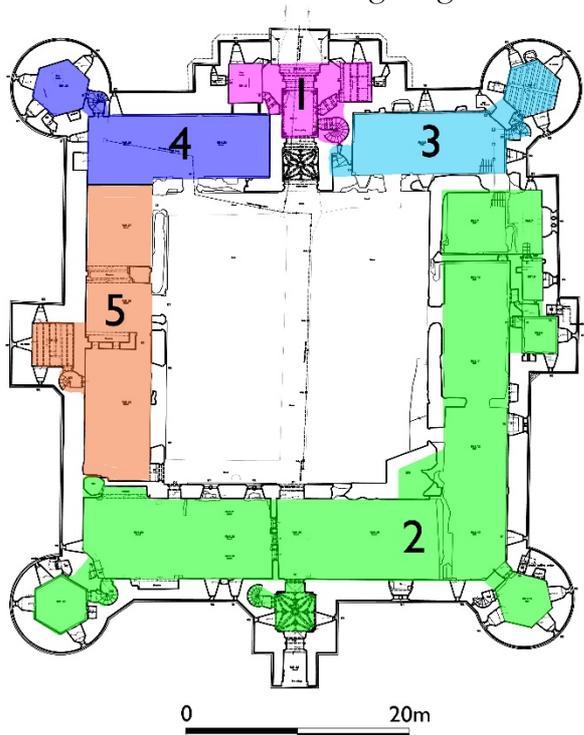
Figure 24 The principal divisions of the courtyard accommodation, lacking intercommunication

the north-east angle of the court. These two ranges (Fig 24, 2) formed a self-contained house arranged primarily on a linear plan, probably with no internal communication with the remaining ranges.<sup>187</sup>

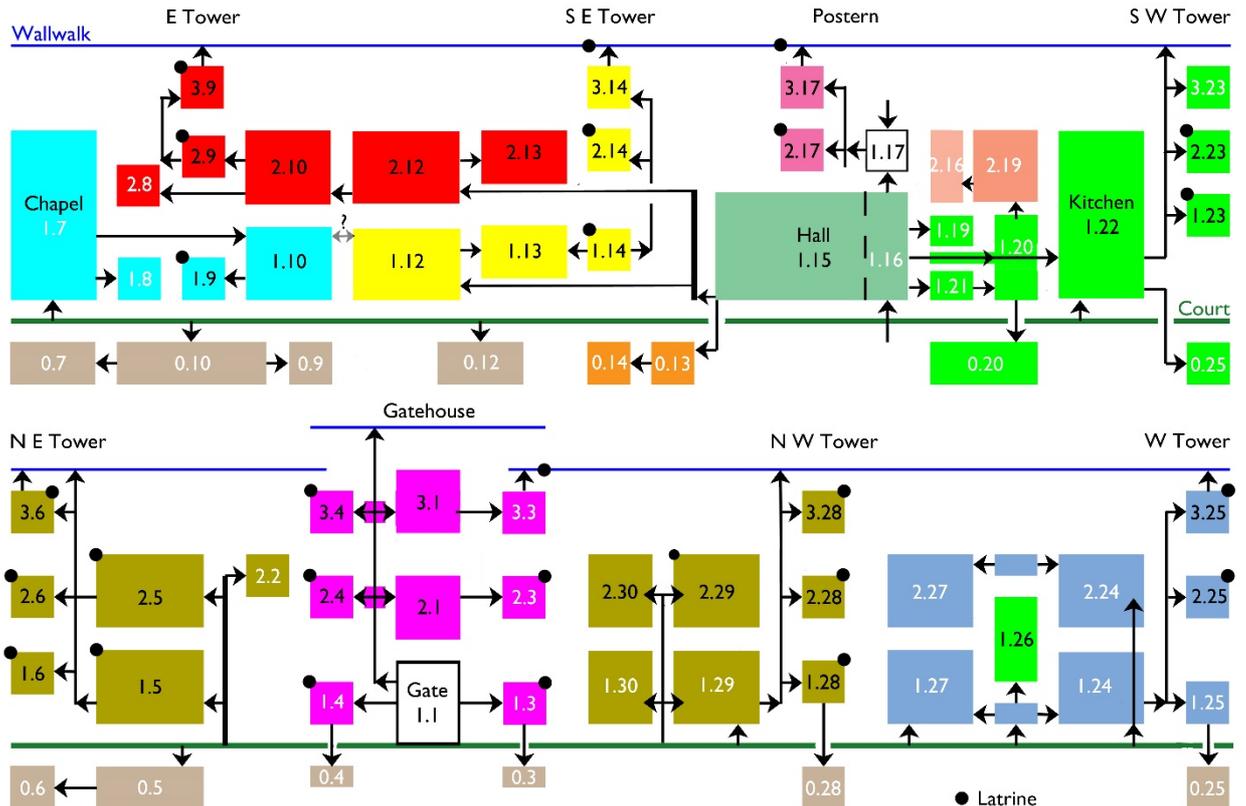
Figure 25 The planning of the castle (developed from Faulkner 1963, fig 11). Room numbers in black denote heated spaces; white, unheated spaces. Arrows point in the direction that doors opened.

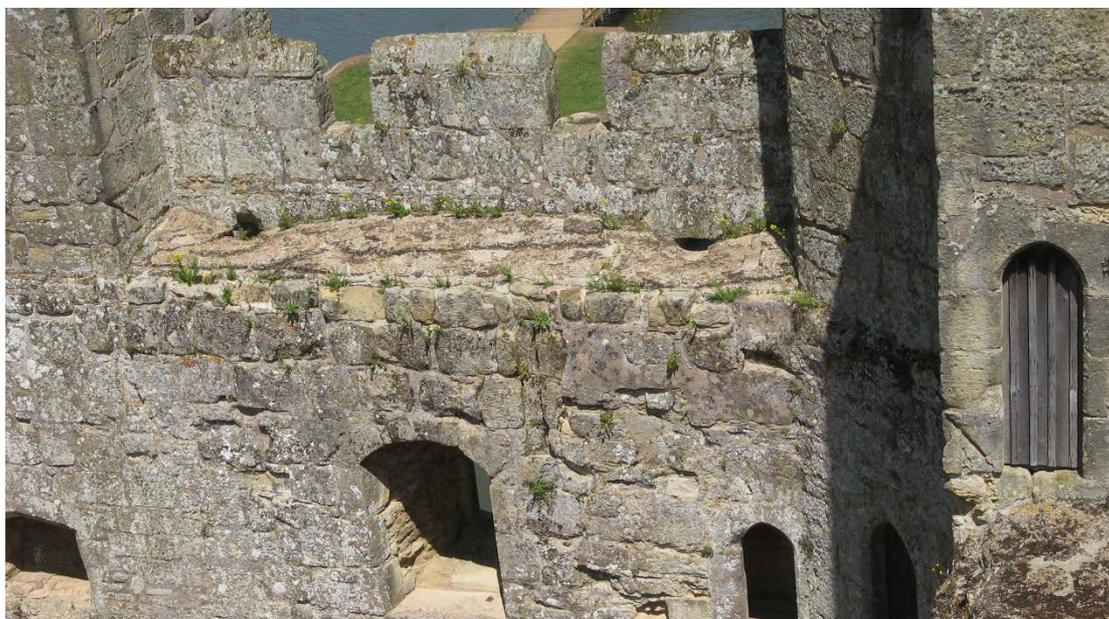
Figure 26 The north-east corner of the courtyard ranges, showing truss positions indicated by wall post slots, flashing lines, and drainage across the wall walks to a pair of drains under the parapet

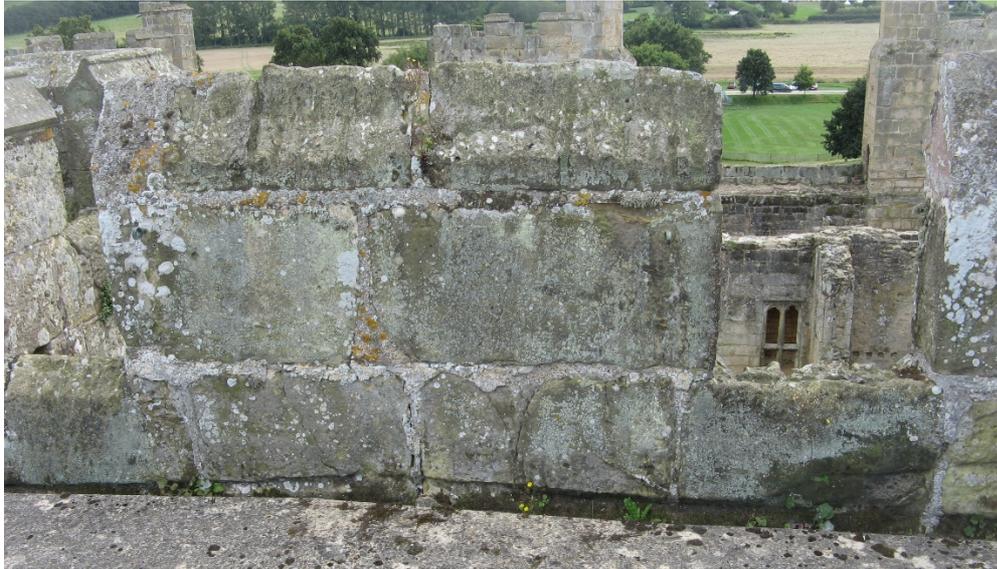
Figure 27 The south abutment of the central block roof of the north gatehouse, showing chase for roof leadwork

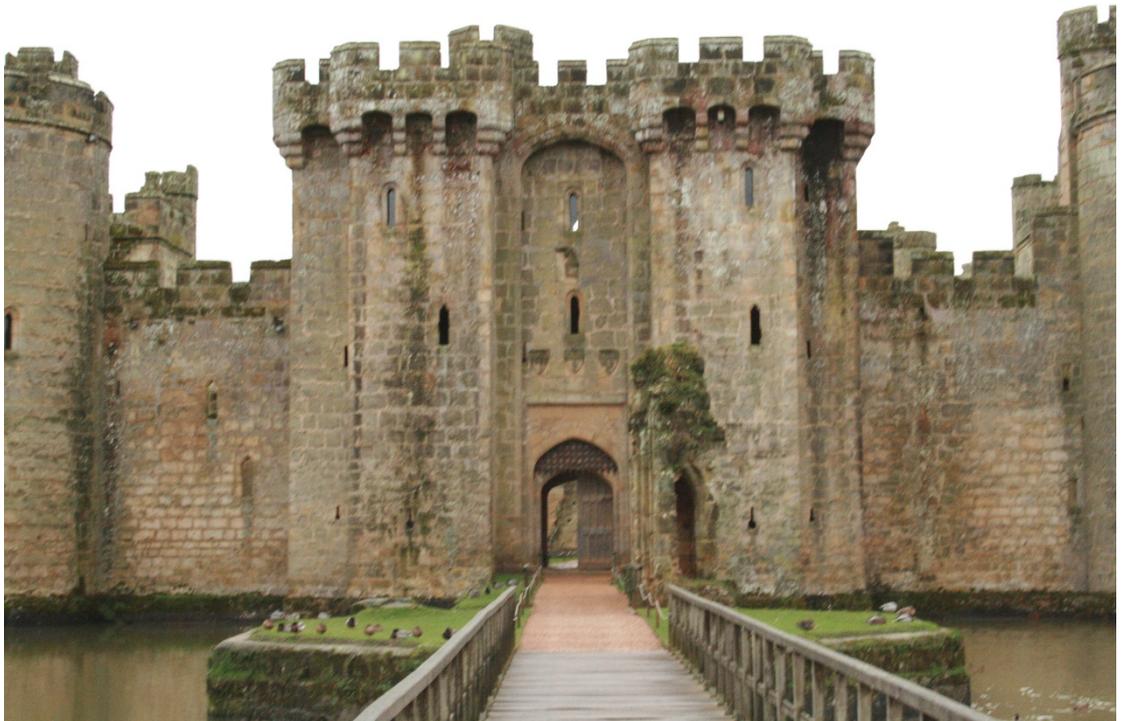
Figure 28 The gatehouse from the north

2.10.41 The portcullis grille to the outer (north) arch partly survives. It is made of oak, visibly iron-clad in its lower part, terminating in the usual iron spikes. Its construction is such that it must have been built in as the stonework went up, and this conclusion is consistent with C<sup>14</sup> dating demonstrating that the timber is of a date range consistent with the construction period of the castle.<sup>199</sup> It is therefore one of a very small number of mostly 14th century portcullis grilles to survive in Britain, one of which, at Hever

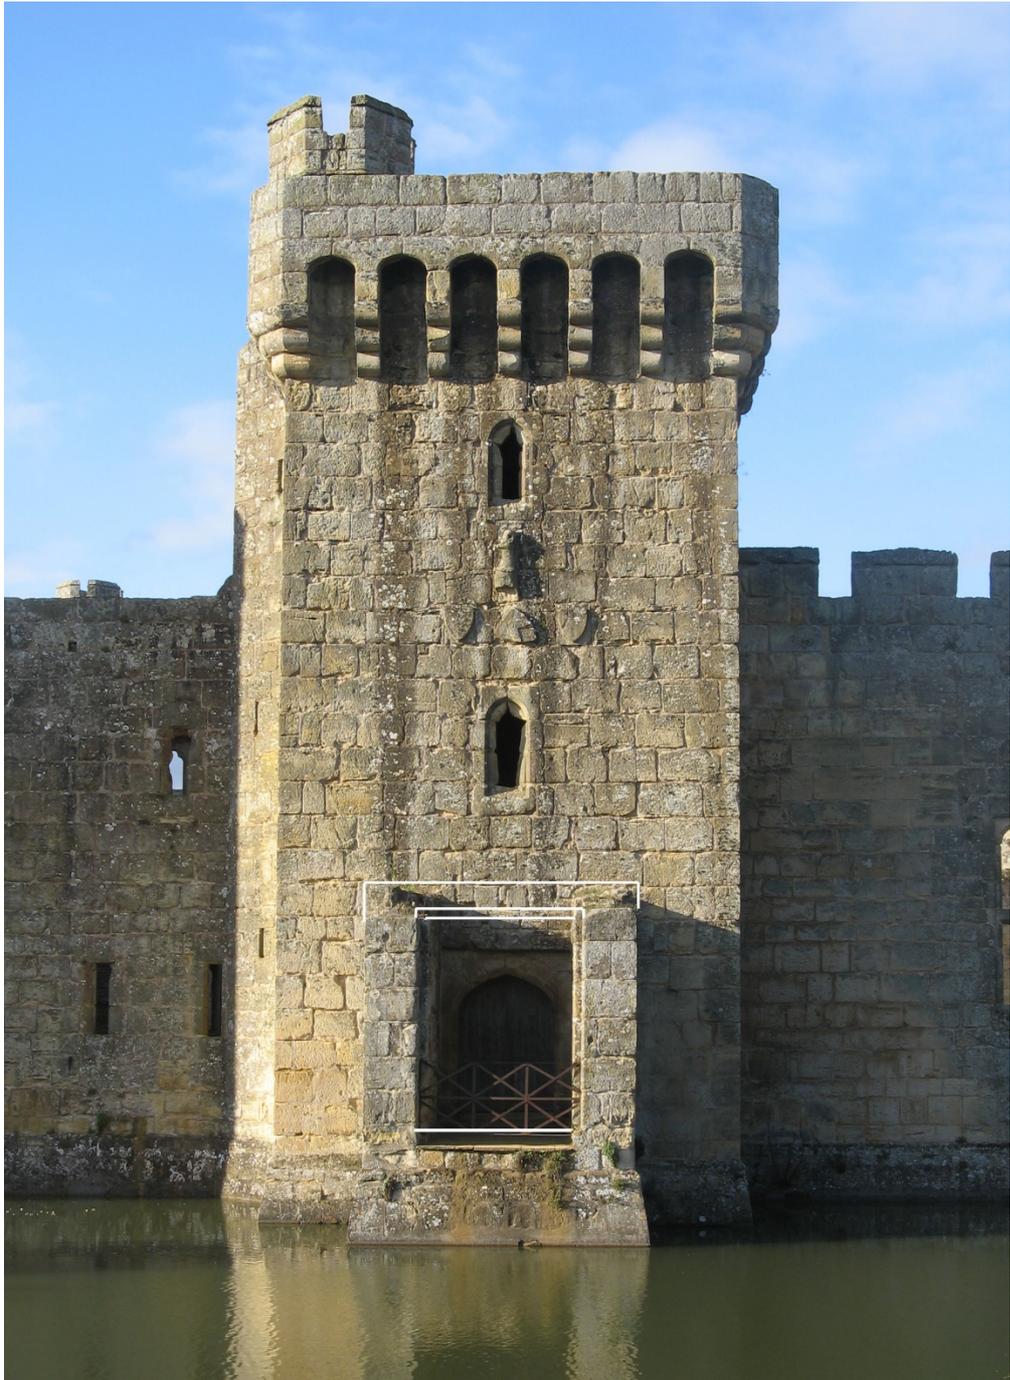
Figure 30 The postern tower from the south, with the roof line of the outer chamber conjecturally restored in white outline, together with the (certain) original floor level
