**BODIAM CASTLE  
ROBERTSBRIDGE EAST SUSSEX  
CONSERVATION MANAGEMENT PLAN  
for THE NATIONAL TRUST**

Part 1: UNDERSTANDING AND SIGNIFICANCE

June 2016

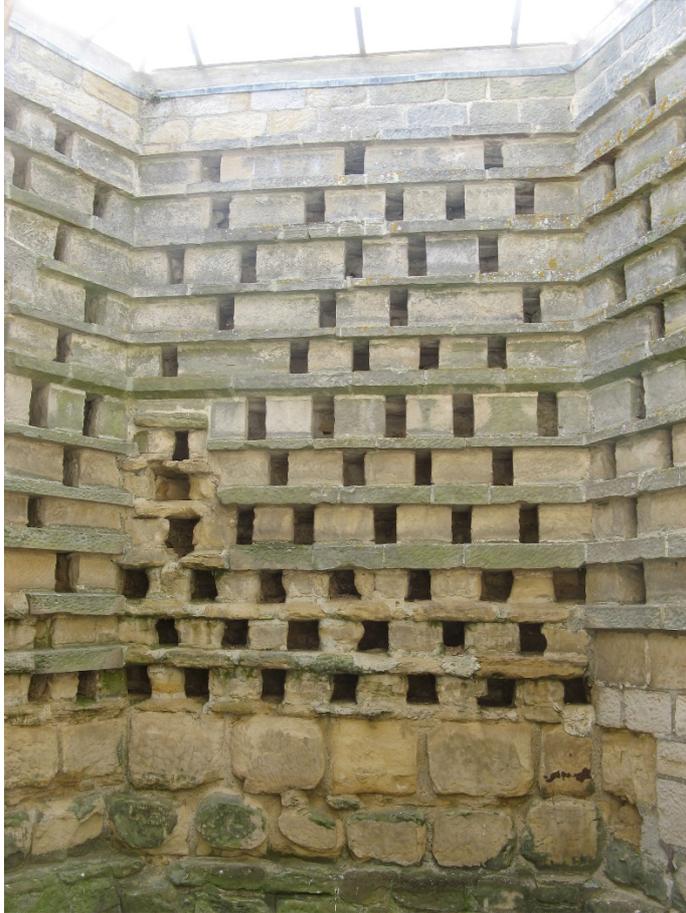
Figure 33 The west face of the dovecote, showing primary nest boxes (weathered) at the base, 19th century rebuilding above. The floor framing was supported on the offset at the bottom of the picture

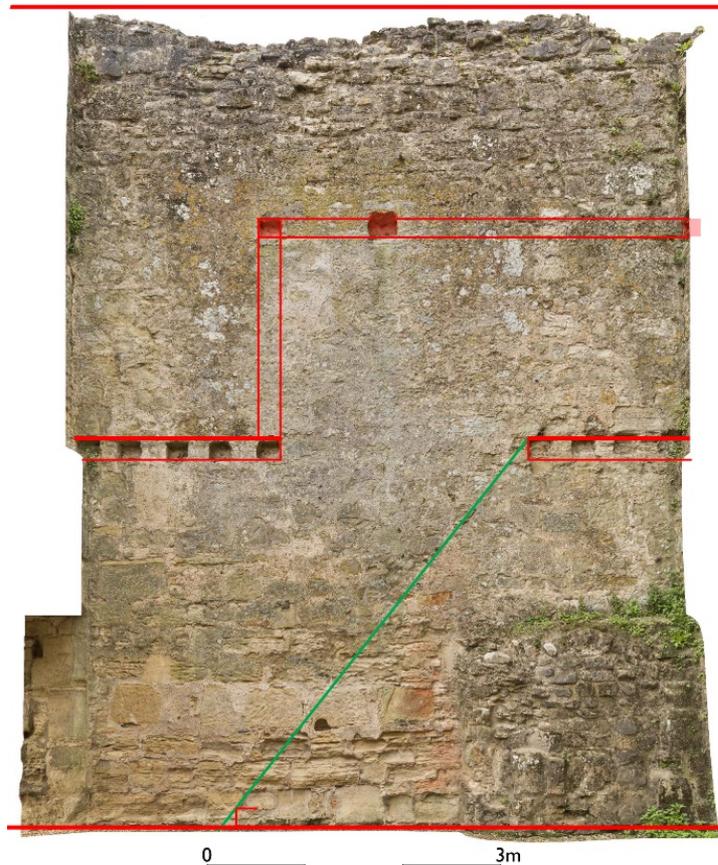
Figure 35 The south end of room 1.24, showing the site of the stair and its enclosed head. The projection at bottom right is the oven in the kitchen

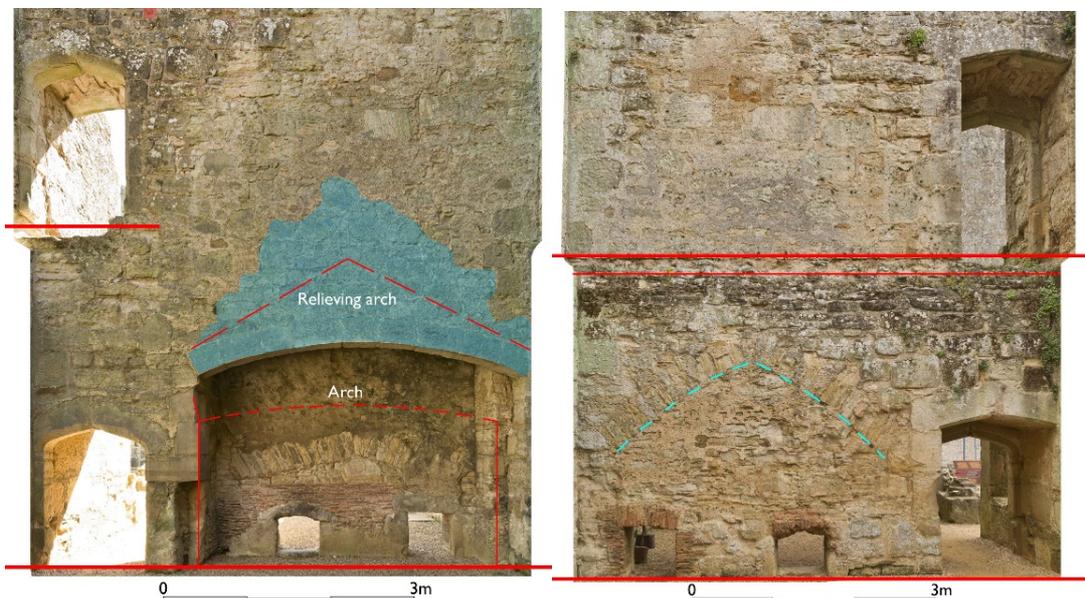
Figure 36 The north (left) and south (right) faces of the wall between rooms 1.26 and 1.27

2.10.92 The hearths are at the core of antiquarian uncertainties about the use of this range. Their stone arches are (early) 19th century, replacing collapsed relieving arches. The north hearth was originally closed at the back like the south, both had west jambs against the curtain, now partly fallen away, and both had shallow arches (not hoods) facing into 1.26 with relieving arches above, the abutments surviving. The south hearth has a tiled fireback below the lower of two relieving arches in the thin back wall, the upper one visible from both sides<sup>257</sup> and the lower only from the north (E20, E19; Fig 36). There are two (similar, but not identical) rectangular openings at hearth level, formed in tile but with stone surrounds on the hearth side. The eastern one has a head significantly burnt on both sides, along with the face of the wall above it on the south (room) side. The north hearth was similar (E17, E18), but with a lower arch (springing at 1.4m rather than 1.75m above floor level), below a relieving arch, the eastern abutment of which survives above the springer for the arch proper (E18). The back wall is lost, but there are jambs of low level openings, here not inset but corresponding with the jambs of the hearths; the northern one projected  $\approx 0.15\text{m}$  into room 1.27 (E5). As with the south hearth, there was a high level relieving arch to back wall, springing from the topmost block of the door jamb (E17). The purpose of the relieving arches in the back walls of both hearths was presumably so that the masonry below was non-structural, making the fire holes though them easy to adjust and renew. The hearths are integral with the

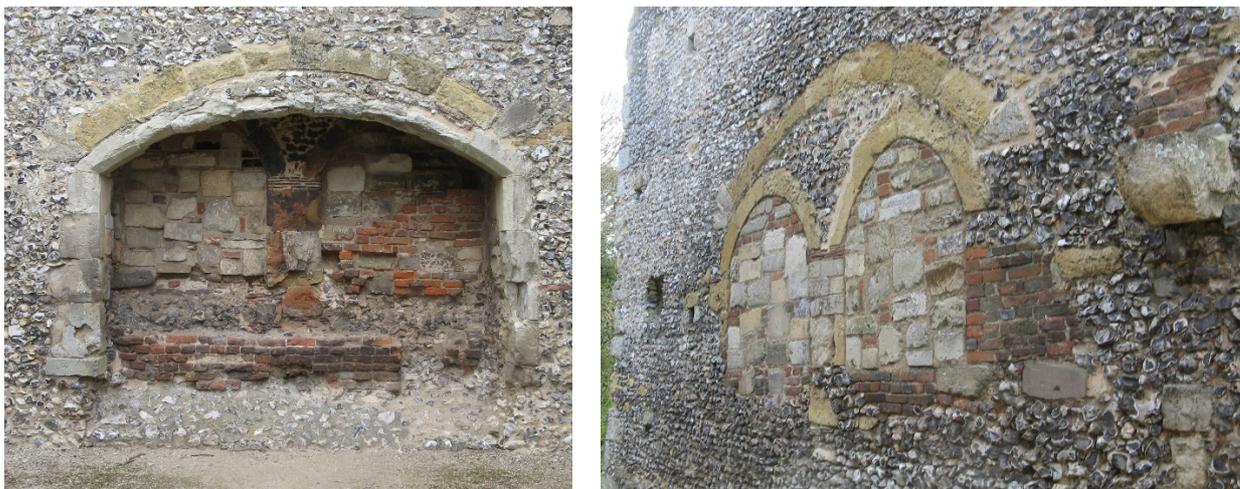
Figure 37 The bakehouse hearth at Bishop's Waltham Palace, Hampshire, 1378-81, showing relieving arches to accommodate the mouths of a pair of ovens. The ovens projected beyond the gable wall, under a pent roof; ground and floor levels were drastically reduced c1440

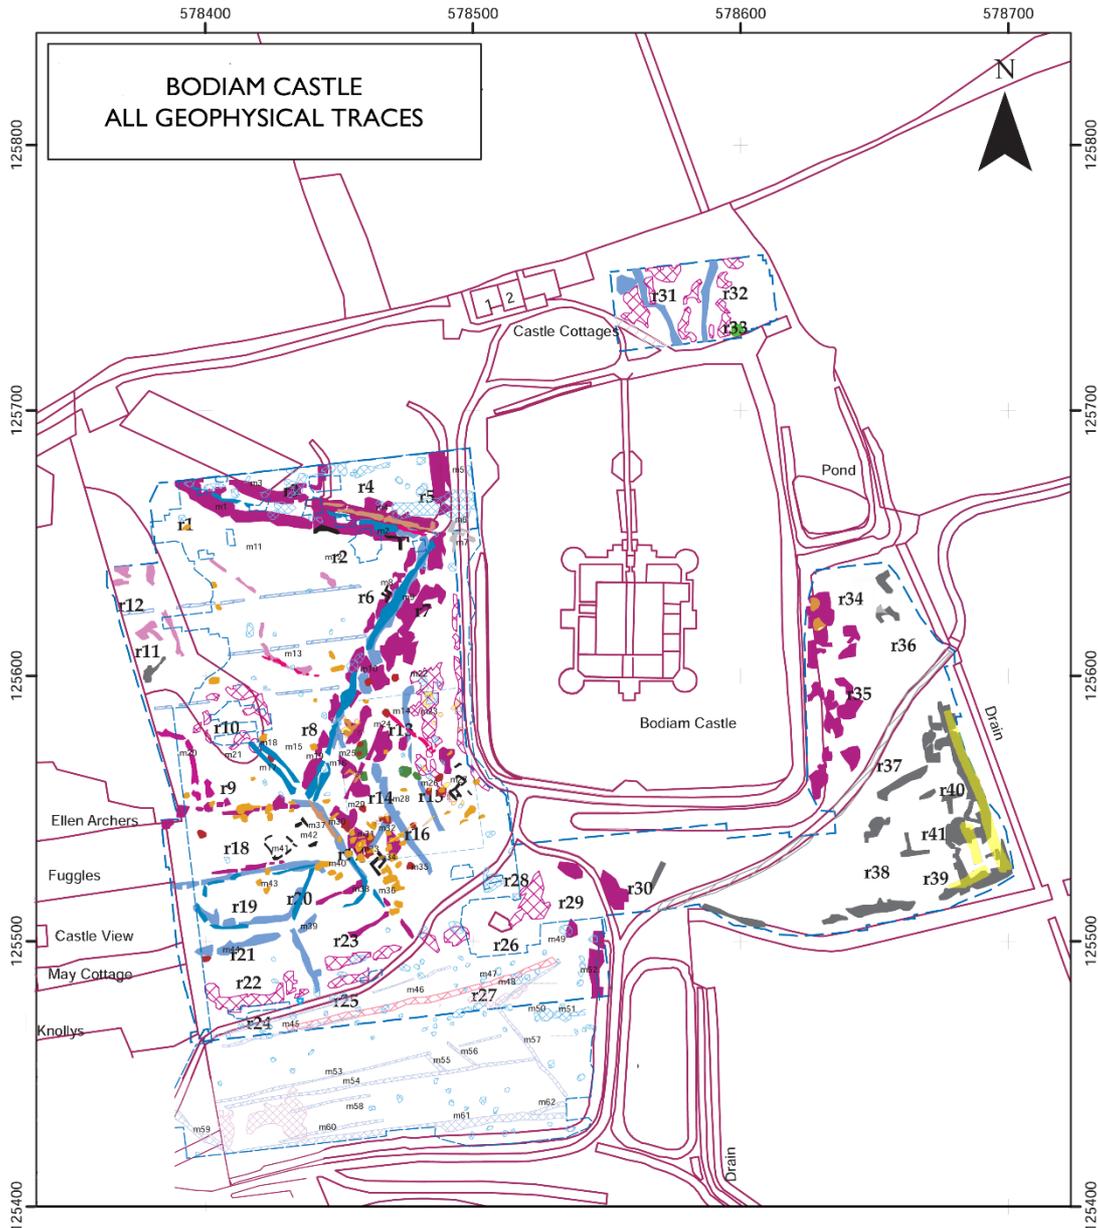
Figure 39 All geophysical results from the immediate castle environs superimposed (*Northwest University/University of Southampton with additions*)

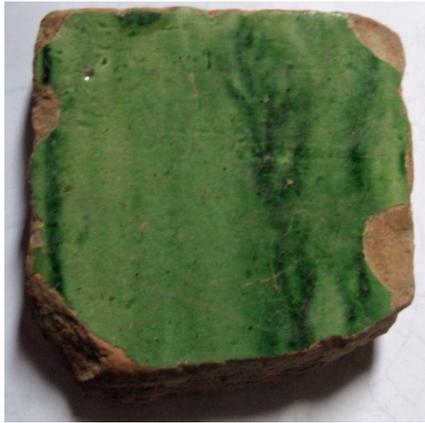
Figure 43 The corner of a high quality floor tile (about a quarter of a quarry originally c230mm square), mottled green glaze over cream slip; the nail hole in the top left-hand corner points to Flemish manufacture (NT/BOD/C/179)

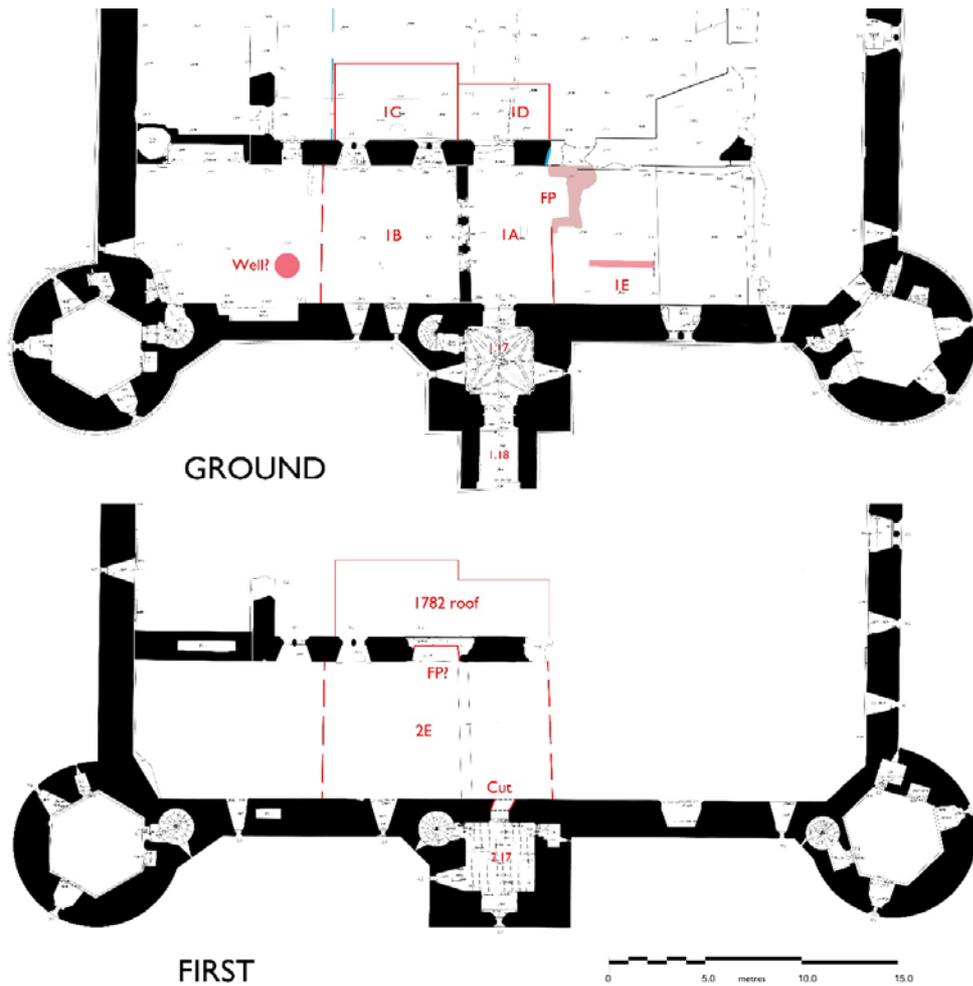
Figure 44 Evidence for post-medieval alterations and additions to the medieval south range

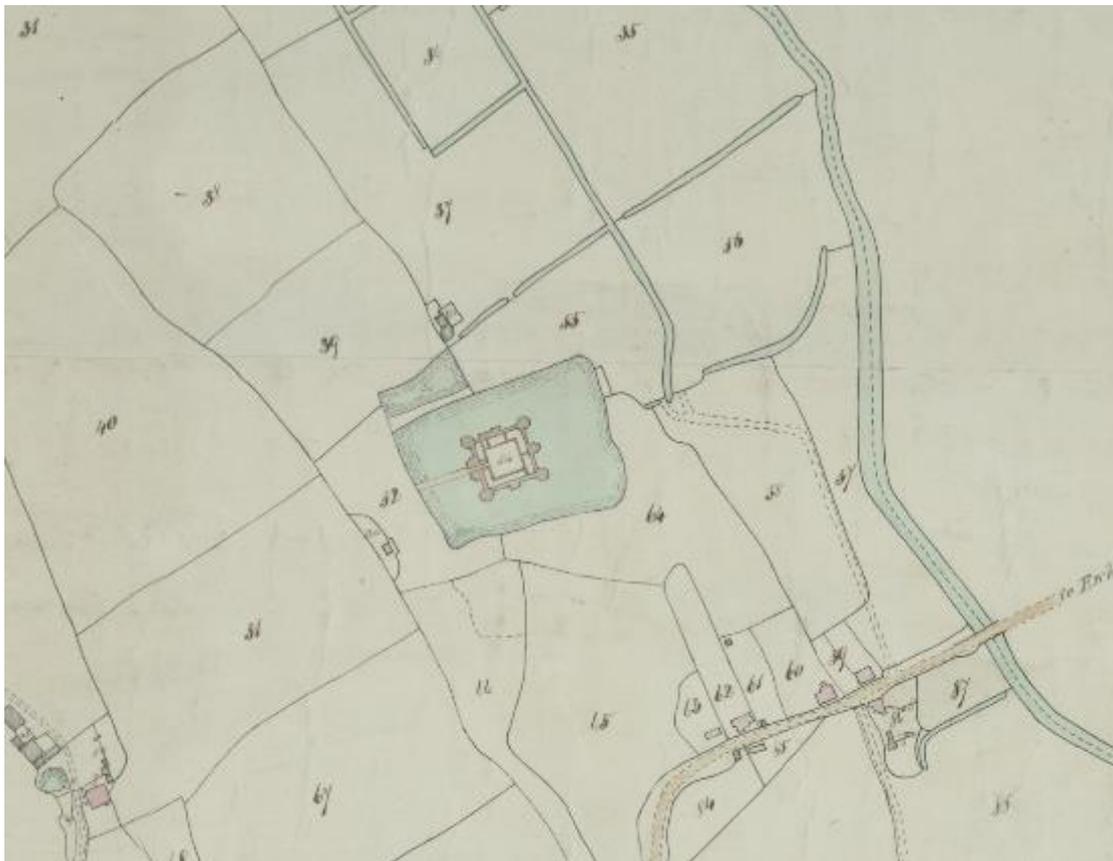
Figure 54 1839 Tithe map (ESRO, TDE 99/1)

2.19.10 The castle remained in Fuller's hands until he died in 1834 and it passed to his heirs. It is shown on the 1839 Tithe map (Fig 54), and few landscape features can be identified that were not present in 1811. Trees are not shown, but the little moat to the east of the castle is clearly full of water and the mill-pond and 'cascade' valley evidently dry.

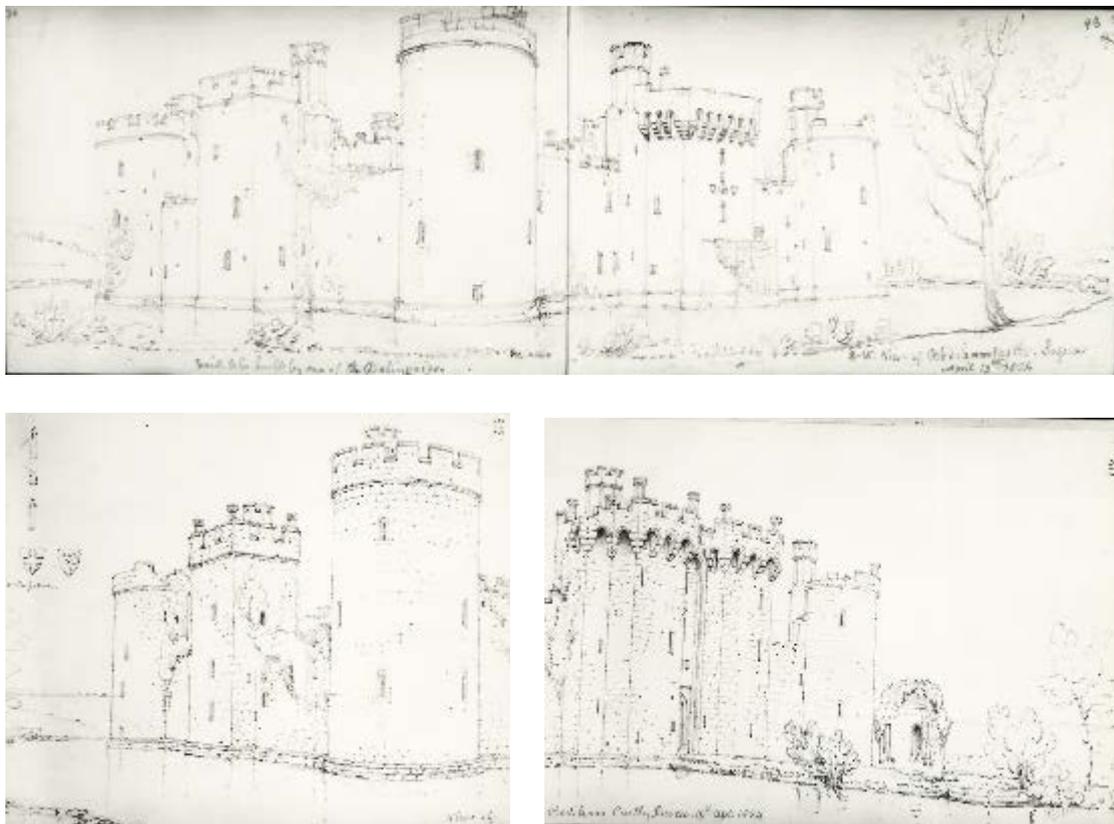
Figure 55 Sketches of the castle from the south-west (top), and north-east (bottom), J A Buckler, April 1824, showing battlements to north-west, west and south-west towers (*British Library, Add MS 36389, f97-8; 36434, f311-12; NT copies*).

2.20.2 Despite Fuller's intervention, the castle seems to have continued to decay in the 20 years after his death. Even allowing for some artistic licence, the Buckler drawings of 1824 (Fig 55) suggest that all three western towers and the postern tower, the east and the north-east towers then had battlements, much as they had had. Yet in L. Neve-Foster's photographs

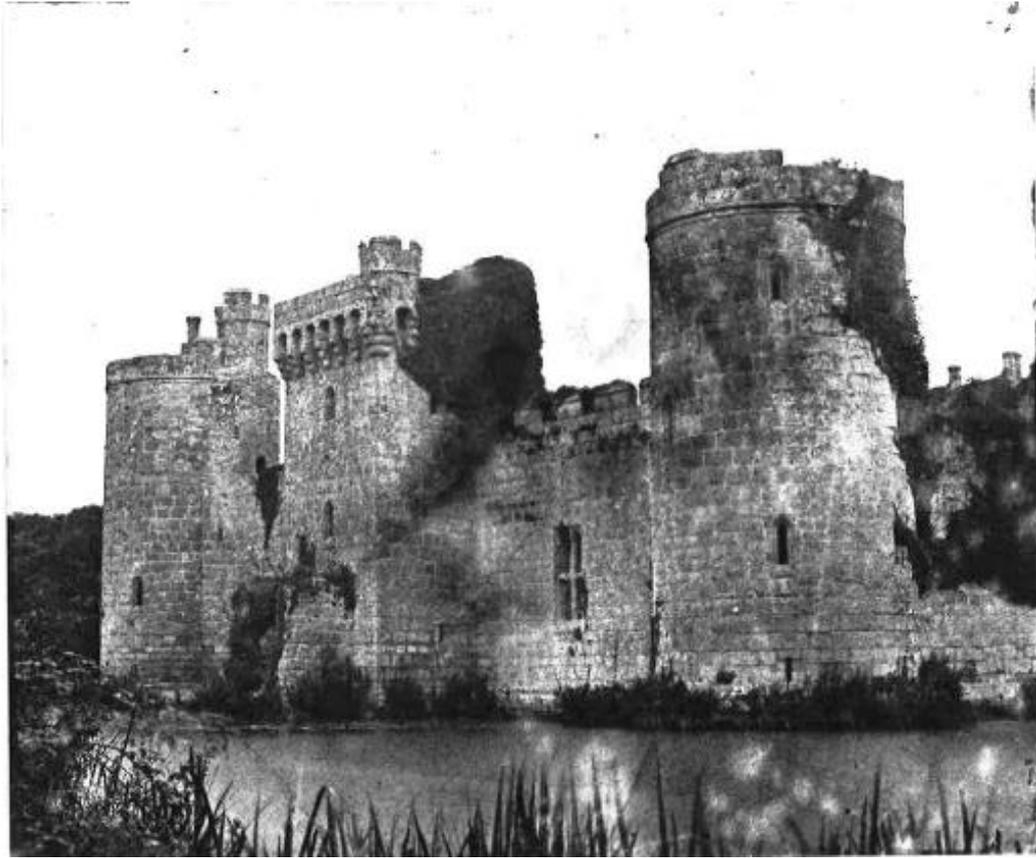
Figure 56 South elevation 1860 (*The National Trust*)

of 1860 (Figs. 56, 57) and another of 1858 by Henry Taylor<sup>403</sup>, almost all of the battlements (including to the gatehouse tower) are missing and the parapets damaged.

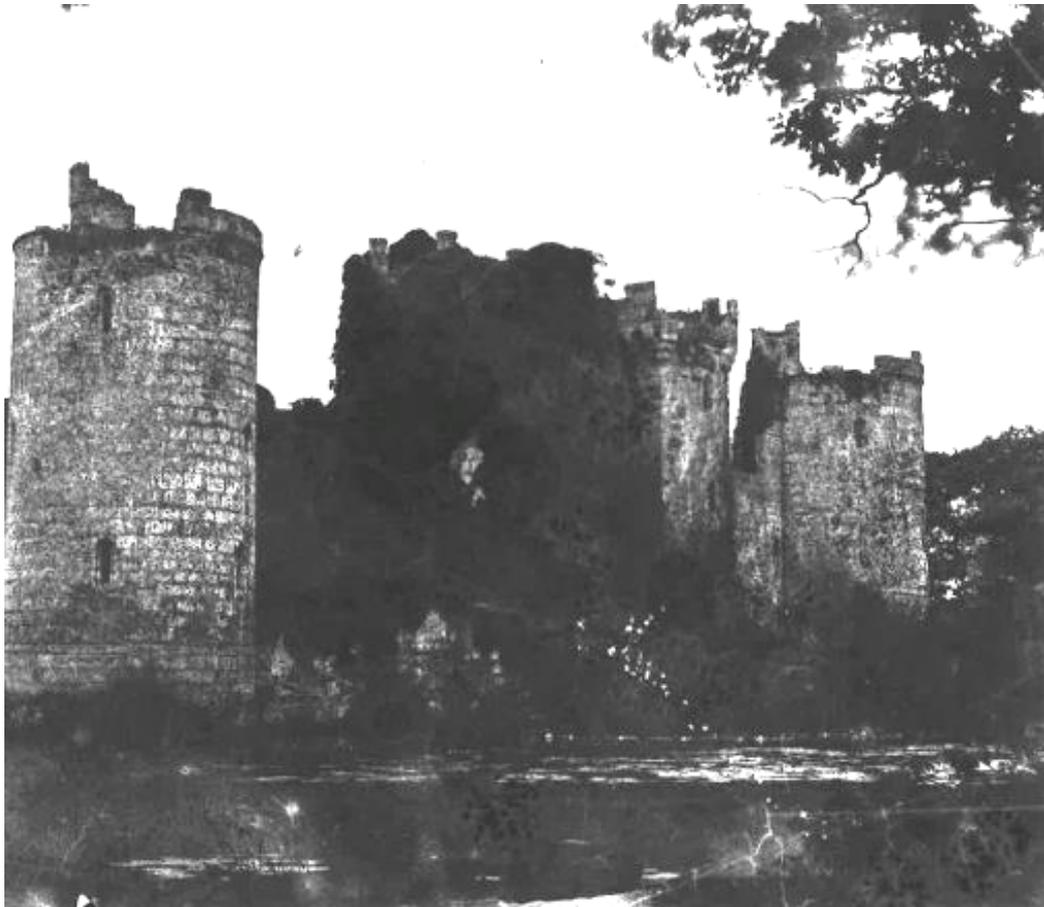
Figure 57 North elevation 1860 (*The National Trust*)

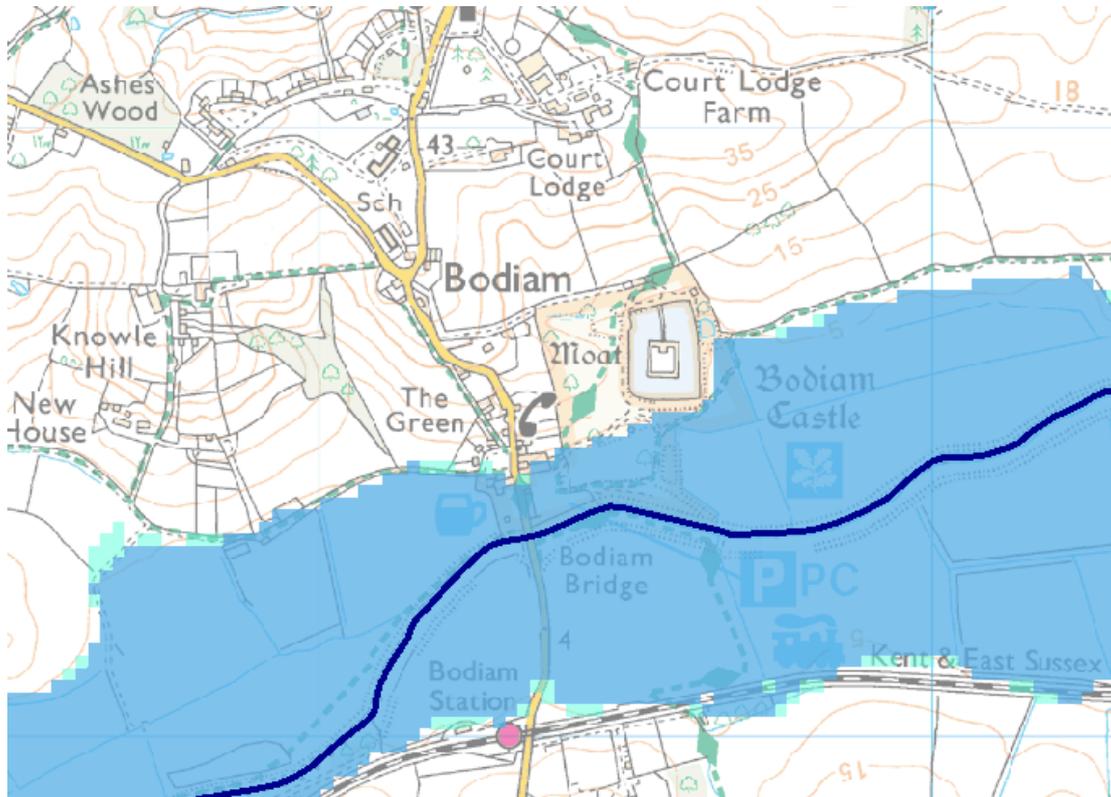
Figure 59 Extract from the Environment Agency Indicative Flood Zone Map showing extents of fluvial flood risk (obtained 16/04/15)

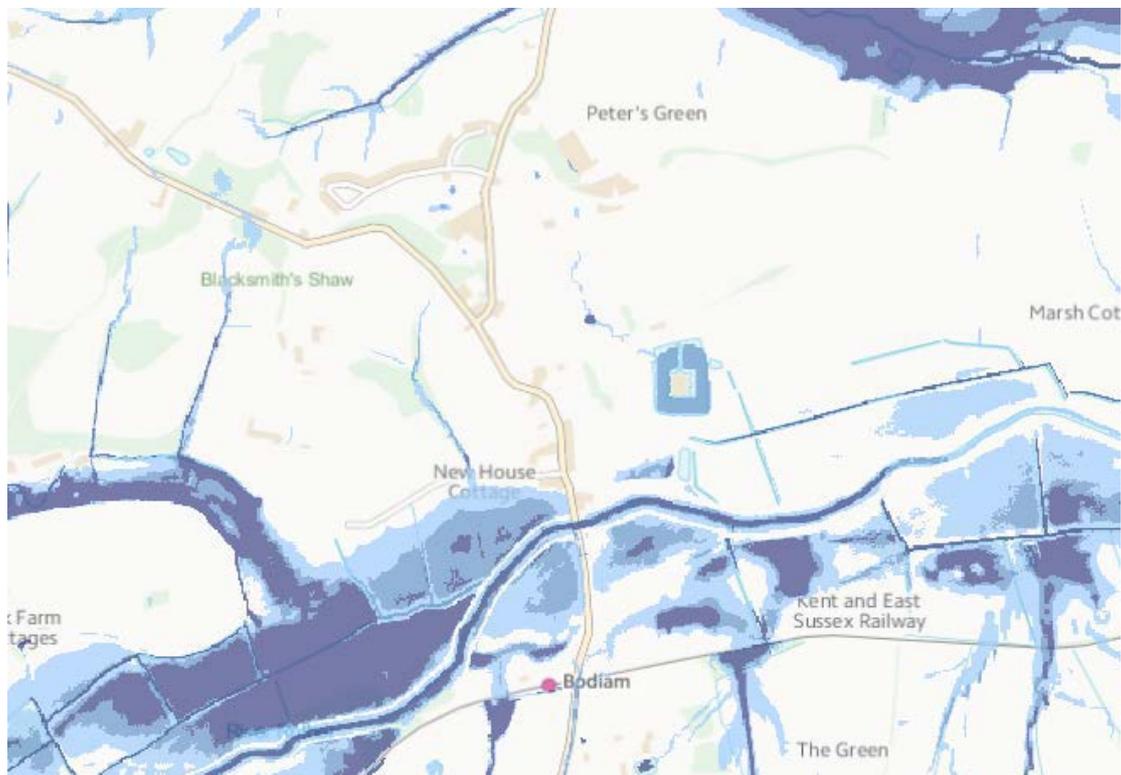
Figure 60 Extract from the Environment Agency Indicative Flood Zone Map showing extents of surface water flood risk (obtained 16/04/15)
