LIVED EXPERIENCE IN THE LATER MIDDLE AGES:
STUDIES OF BODIAM AND OTHER ELITE LANDSCAPES
IN SOUTH-EASTERN ENGLAND

Edited by Matthew Johnson

Abstract

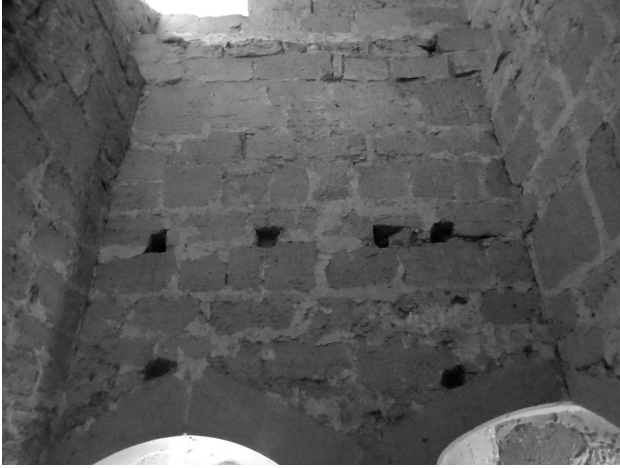
Fig. 3.11: Evidence for inserted floors, western ground floor room of gatehouse. Photo by Penny Copeland.

also Chapter Five). There is also evidence in many of the tower rooms of inserted floors to provide more space (Fig. 3.11). It could be related to agricultural storage but when and why this was done is not clear.

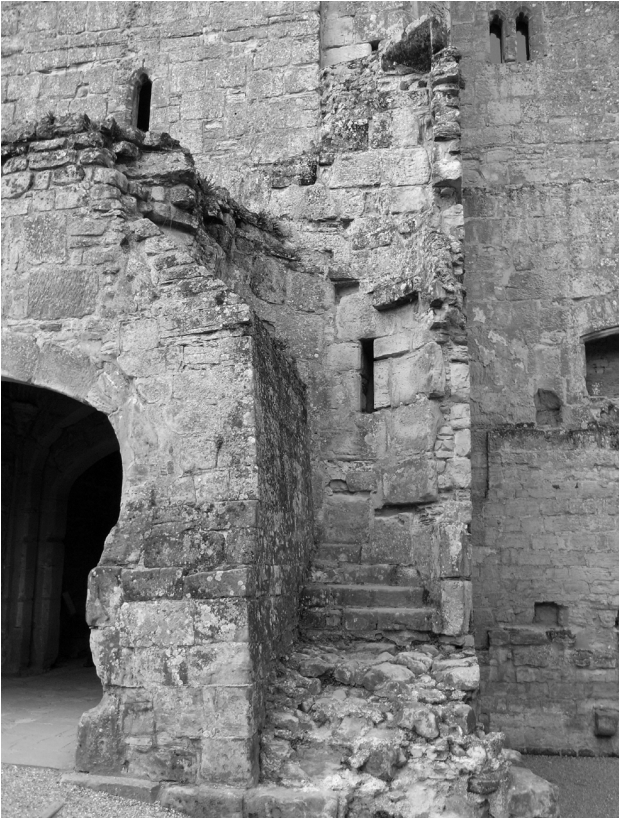
Fig. 3.14: Buttress against gatehouse, built up against stair to reach chamber. Photo by Penny Copeland.

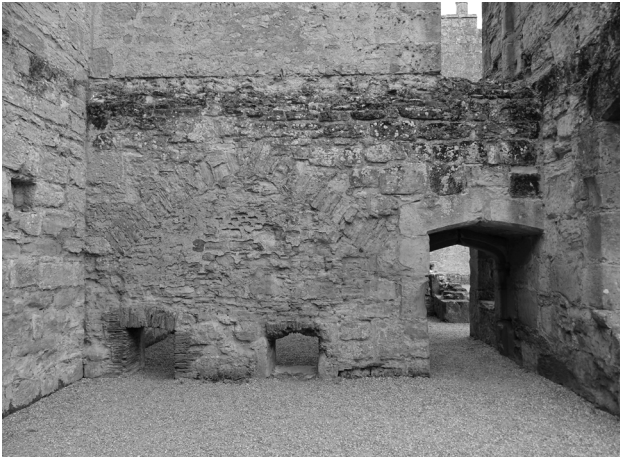
Fig. 3.15: Southern cross wall of western range showing relieving arch and flue or stoke holes. A further retaining arch is visible on the northern side. Note knife sharpening effect on doorway. Photo by Penny Copeland.

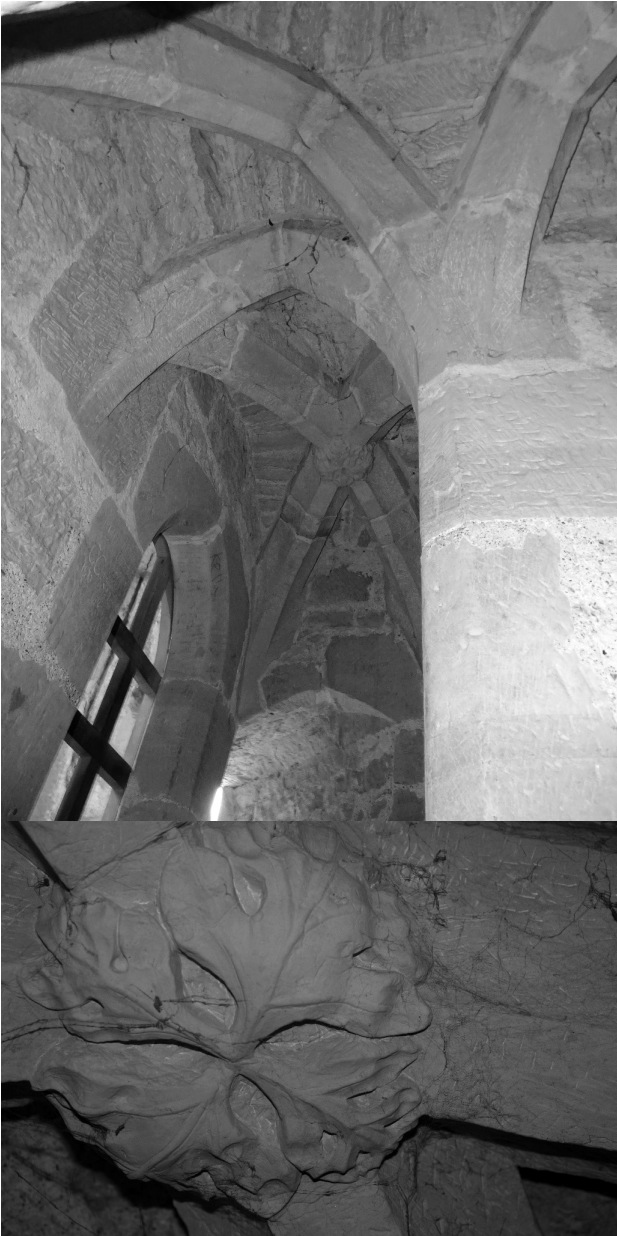
Fig. 3.17: Leafy boss in the first floor corridor of the gatehouse. Photos by Penny Copeland.

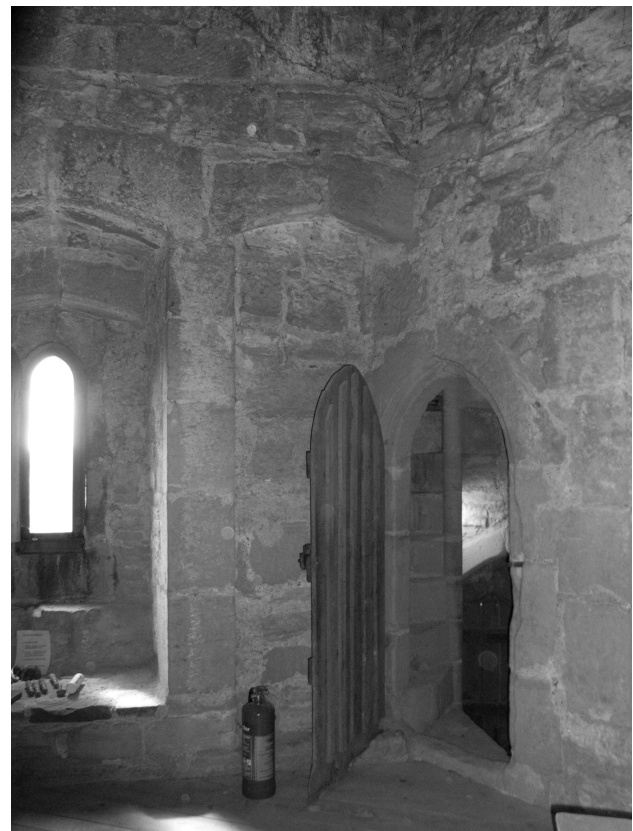
Fig. 3.21: Recess with lintel in wall of chamber floor of north-east tower. Photo by Penny Copeland.

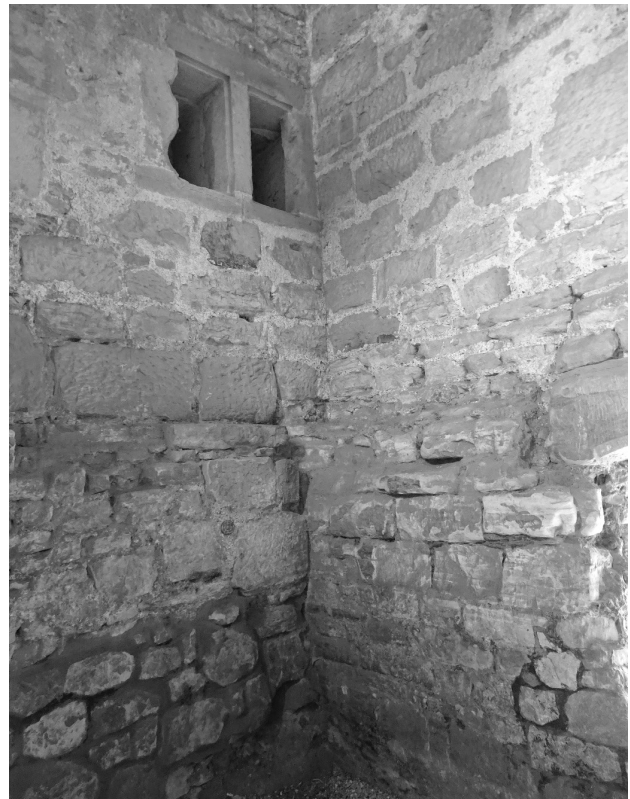
Fig. 3.23: Straight joint and rebuilt walls in basement level of east tower, also showing cupboards where stair access would normally be. Photo by Penny Copeland.

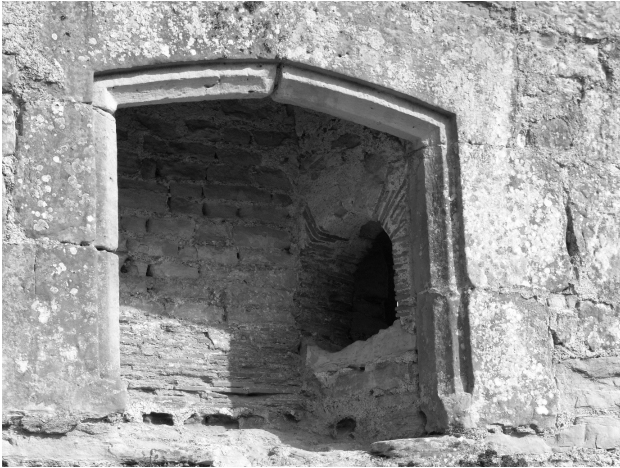
Fig. 3.24: Fireplace in main range that connects through to east tower recess. Photo by Penny Copeland.

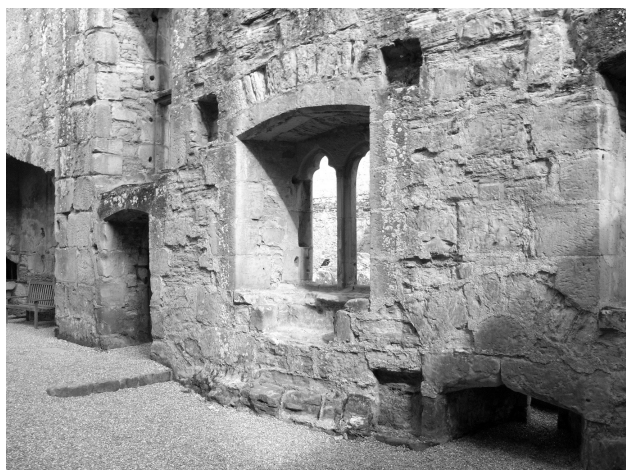
Fig. 3.26: Window to basement of service range excavated by Curzon, also showing the substantial mortices for wall partitions. Photo by Penny Copeland.

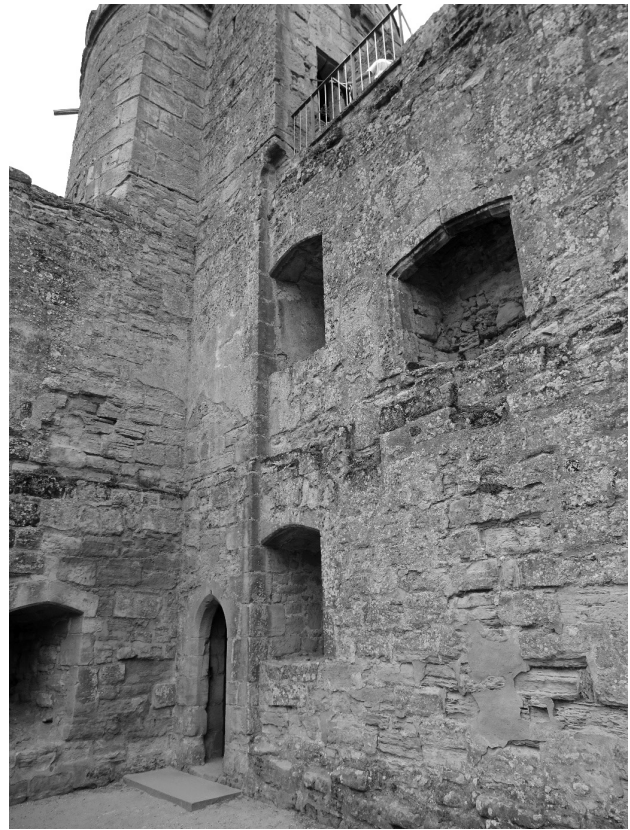
Fig. 3.30: Possible straight joint between north-west tower and north wall. Photo by Penny Copeland.

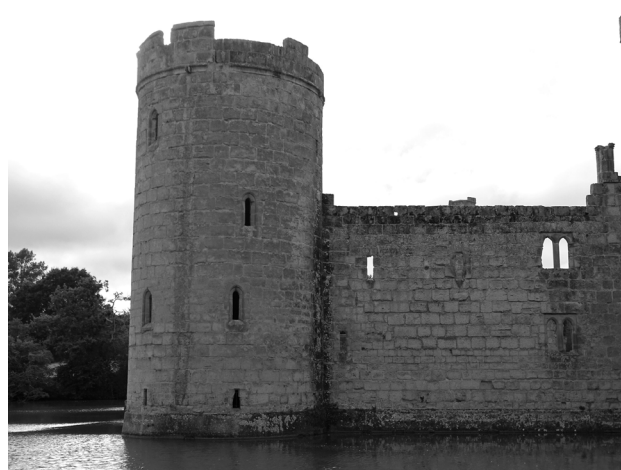
Fig. 3.31: Southern section of the east curtain wall showing different building seasons. Photo by Penny Copeland.

The change in work between seasons is clearly visible in the stone work of the southern part of the east curtain wall (Fig. 3.31). The south-east tower has been completed up to the top of the ground floor window and the wall to the north is staggered downwards to a lower level. The top few courses are completed in smaller stones. When the next building season arrived, larger stones were used and had to be cut to shape over those in place. No attempt was made to continue a course.

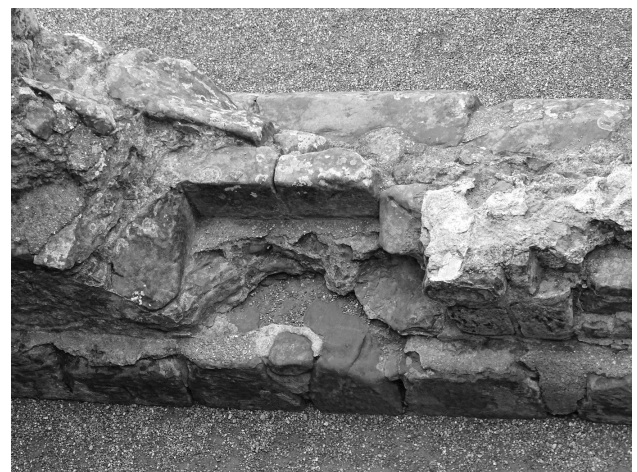
Fig. 3.32: Window seat and plinth in northern range often interpreted as stables. Photo by Penny Copeland.

The north range west of the gatehouse has been identified as stables, and the position is at first sight a logical one. However the doorways appear to be too narrow for this purpose, and the plinths for a suspended floor argue against this, although GPR anomalies indicate possible subsurface drains both here and on the other side of the gatehouse (Fig. 3.10, E1-E3 & F2). Indications in the GPR results of foundations of a cross wall between 'stables' and western service range should also be noted here (D4 & D5). There is also evidence for a large window with a window seat (Fig. 3.32) – an unusual feature for a stable. If the stables are indeed not within the central court, they must be elsewhere, and we suggest below that they may have been sited on the ridge to the north as part of a detached 'base court'.

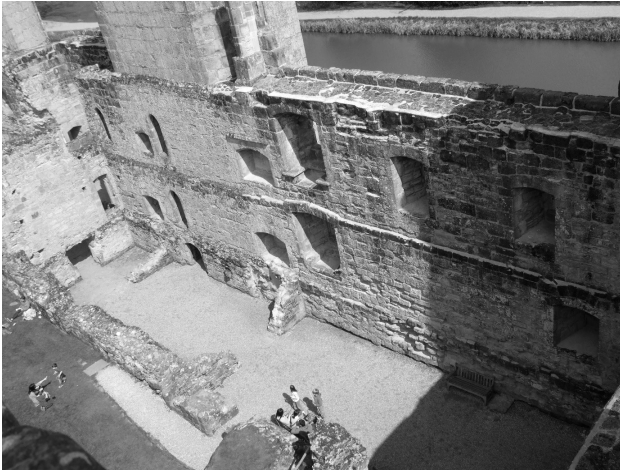
Fig. 3.33: Suites at the upper end of the hall, viewed from the summit of the southern gatehouse; see also Fig. 3.7. Photo by Matthew Johnson.

At the upper end of the hall, running up the east range, are two suites, each indicated by fenestration and other features and divided up by now-vanished timber partitions (Figs 3.7 & 3.33). Both consisted of an unheated outer room, an inner chamber with fireplace and window seat, and a further inner chamber with fireplace and window seat facing onto the courtyard. Both inner chambers have doors to rooms in the east tower, which do not intercommunicate. This is the only tower where these two levels do not have a connecting stair. The lower suite has a door into the chapel, while

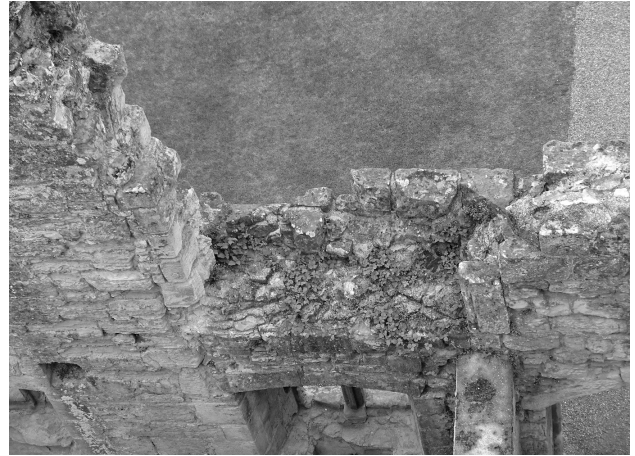
Fig. 3.34: View down only narrow window jamb to west, and rebated door jamb to right. The door jamb sits slightly over the triple door wall at the end of the Great Hall. Photo by Penny Copeland.

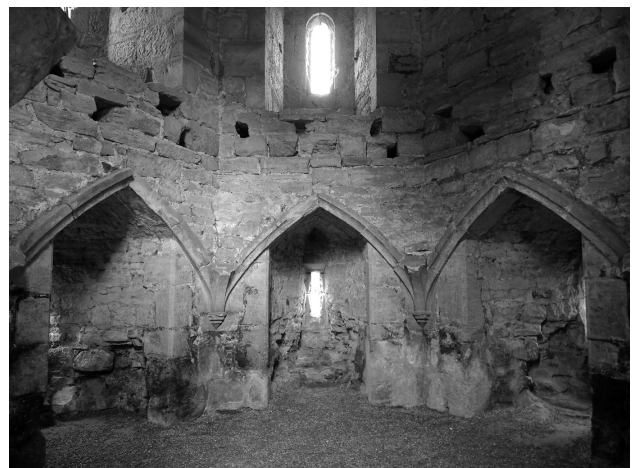
Fig. 3.35: Vaulted basement room of the south-east tower. Photo by Penny Copeland.

and to the floor above. The south-east tower has a vaulted basement (Fig. 3.35). The vault is now largely destroyed but enough remains to indicate that it was finely constructed in a manner similar to the gatehouse vaults. The function of this room is not certain but its location at the lower end of the private apartments and just off from the Great Hall suggests it may have been a strongroom similar to rooms found at Penshurst, Ightham and Great Chalfield. The south-west tower has a well in the basement and a dovecote in its upper storey; this tower was heavily restored by Cubitt and later Curzon (Fig. 3.36). Large parts of the dovecote have been entirely rebuilt but enough remains to demonstrate that it was an original feature of the 1380s.

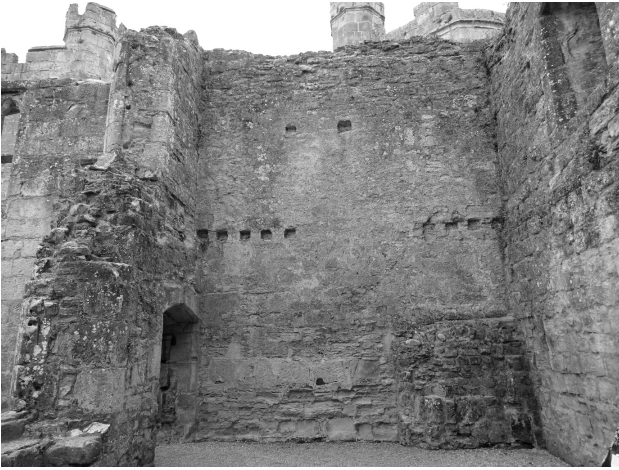
Fig. 3.38: Floor joists with gap for trimmer and faint scar in surviving plaster for staircase from ground floor against the external northern wall of the kitchen. Note the rebuilt oven below. Photo by Penny Copeland.

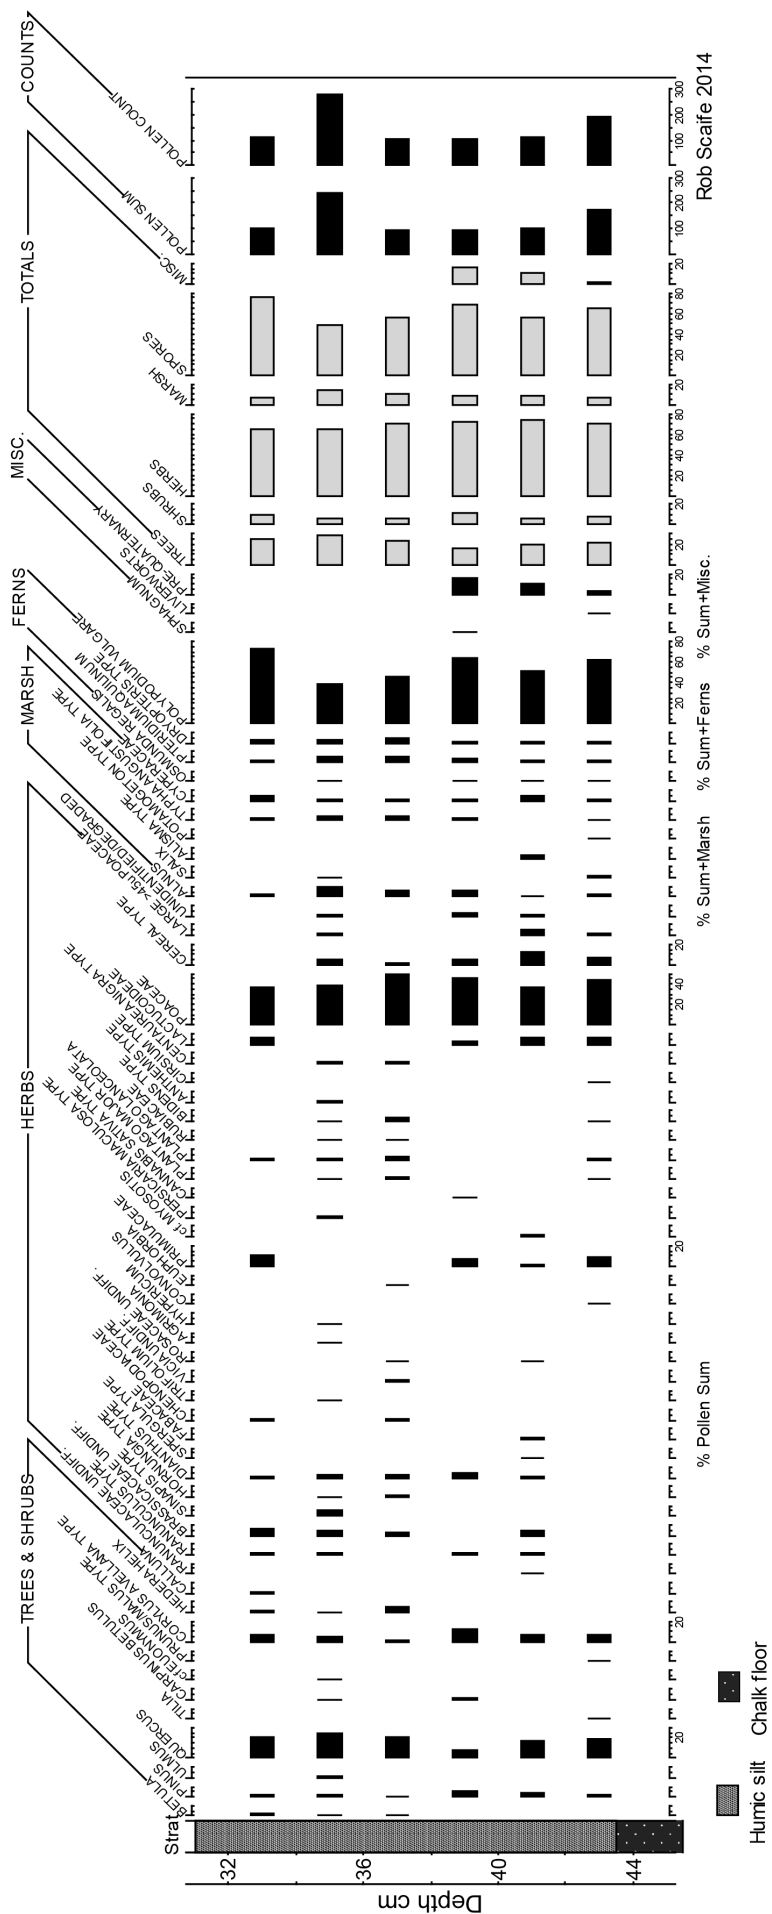
Fig. 5.5: Pollen diagram from Profile A2.

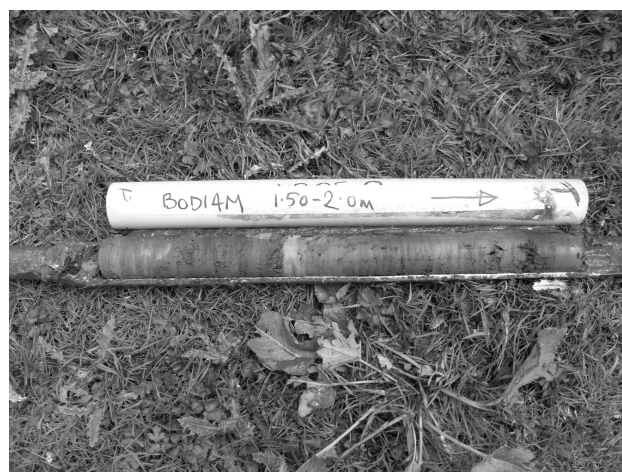
Fig. 5.11: The lowest 50 cm of Core F, in the east pond.

This site had a 2 m thick, continuous sequence of largely humic mineral sediment and some peat (Table 5.G; Fig. 5.11). The very thick, undisturbed sediments under a layer of compacted leaves at c. 60 cm suggest that the area has been a pond for a considerable time. Above c. 60 cm, the stratigraphy consists of sand, gravel, and other dumped material. A radiocarbon measurement from a wood twig at 118 cm provided a date of 130+/-BP. This date can be calibrated to either 1670–1780, or to 1800–1950 (the calibration curve has two peaks at this point). The former date, close to the abandonment of the castle, is much more likely given the stratigraphic location of the sample. The 50–60 cm of structured sediments between this twig and the fill material suggests that the pond was undisturbed for many years after the castle's abandonment, before it began to see use as a dumping ground in conjunction with the landscape work of the 19th and 20th centuries.

Pollen analysis was only performed in the more structured sediments below 60 cm. There is a distinct division between the pollen assemblages above and below c. 1.70 m (Figs 5.11 & 5.12). The stratigraphy is very similar on either side of this divide, so it is probable that this small pond remained similar in form and structure over time, despite changes to the fringing vegetation. In the earlier phase, alder was dominant on the site, with some hazel and oak and few grasses, algae, and ferns. This habitat later changed to an open pond with fen herb type vegetation, including willow, with higher amounts of oak and diverse grasses and cereals, and lower numbers of wetland taxa and alder.

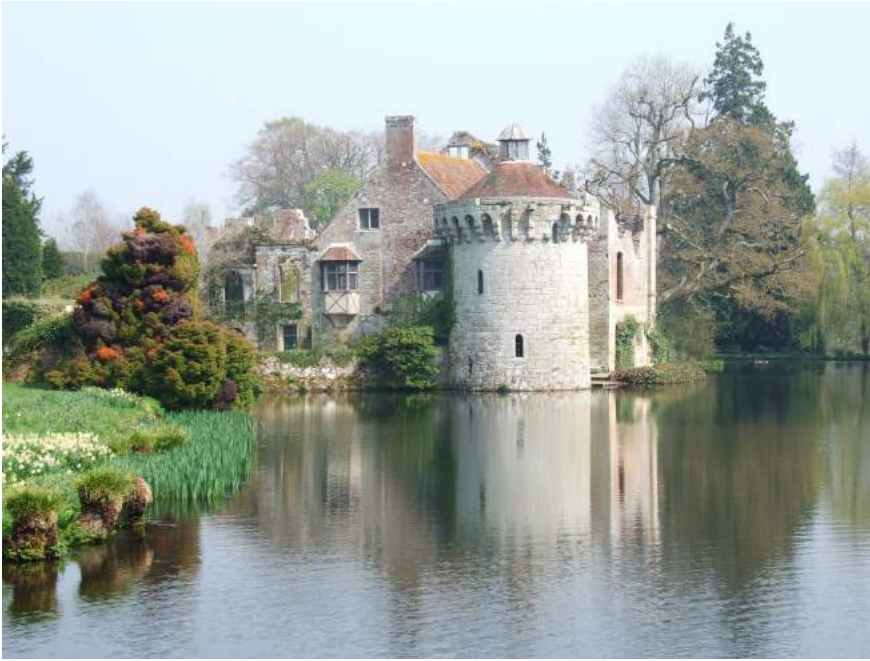
Fig. 6.3: The inner court of Scotney Castle and moat, from the south-west. Photo by Matthew Johnson.

The standing fabric of Scotney Castle has been the subject of a thorough analysis and interpretation, published in *Archaeologia Cantiana* (Martin *et al.* 2008; 2011; 2012). The castle is moated, and the inner court rises directly from the water, without a berm, as at Bodiam (Fig. 6.3). The water surrounding the castle is fed by streams from the south and south-west, and held back by an artificial dam to the west. This body of water has three islands within it, two of which have definite structural evidence from the Middle Ages. The middle island appears to have functioned as an outer court, with stables and other buildings. It was approached via a bridge from the north-west, as it is

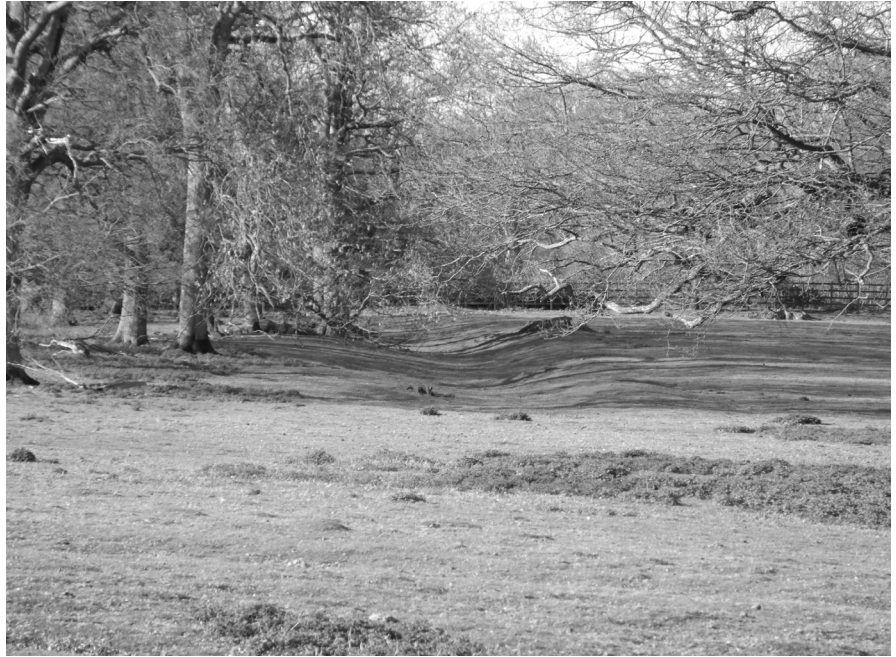
Fig. 6.4: Sunken approach to the castle, as viewed from the north-east looking up towards the higher ground. Photo by Matthew Johnson.

castle (Fig. 6.4). A second 60 x 60 m resistivity survey was targeted over a number of large, possibly worked, stones within a copse along the southern slope of the valley, largely for the purposes of archaeological instruction in geophysics. The results of this survey were, unfortunately, inconclusive (Figs 6.6 & 6.7).

The 2011-2012 topographic survey confirmed the presence of a slightly sunken linear earthwork feature running roughly parallel with the Sweetbourne and continuing towards the castle (Figs 6.4 & 6.5, F1). When georeferenced with the 1757 Clout map, this topographic feature conforms to the area marked 'Lane' on the map and the field boundary in the 1870 Ordnance Survey Map. The resistivity survey

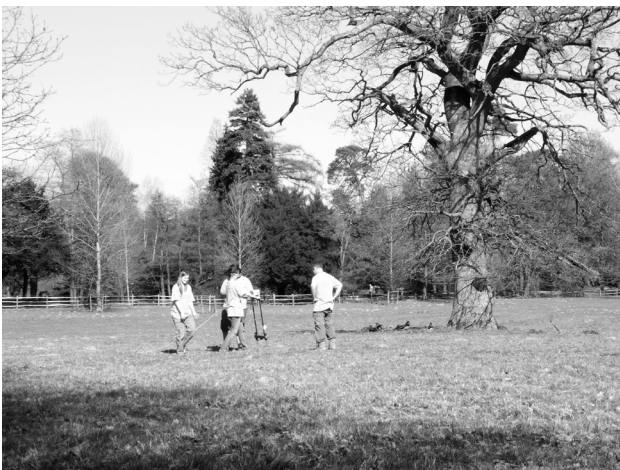
Fig. 6.7: Geophysical survey in the valley bottom, 2010. Photo by Matthew Johnson.
